Ferry Safety Investigation Report

Children overboard at Riverview College Ferry Wharf,
Riverview, NSW, 16 February 2023

Investigation Reference IO2038

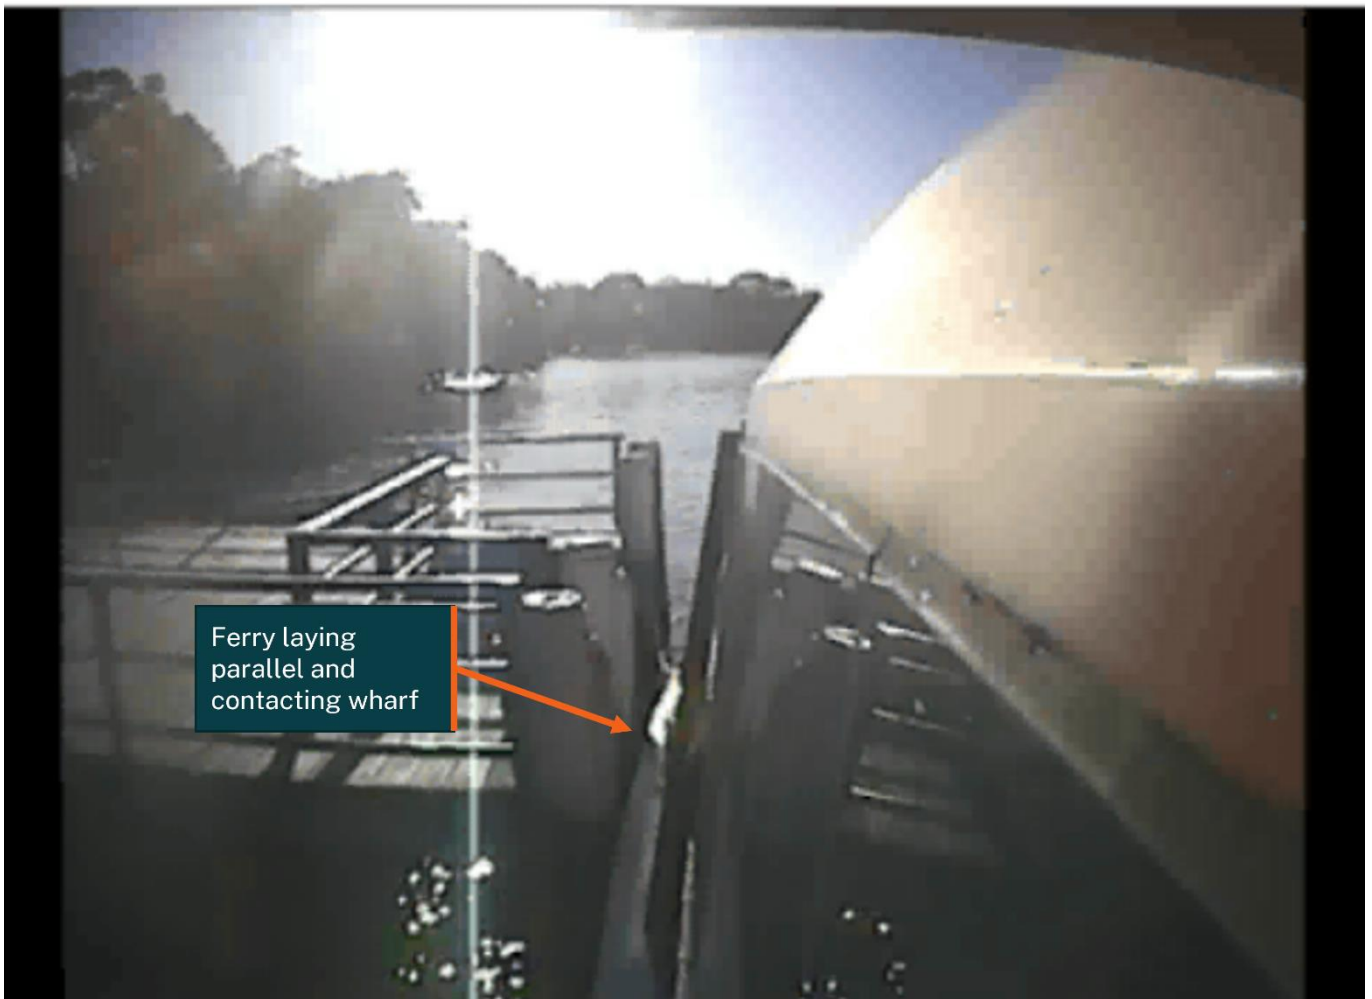
Figure 3: Onboard portside CCTV showing position of vessel alongside the wharf before the incident

- 1.9 Between 0809:36 and 0811:27, the Master and Deckhand made repeated attempts to safely position and secure the vessel, lining up the forward gangway door with the wharf's western platform. Each attempt resulted in the ferry stern (rear) drifting away from the wharf. On each occasion, the Deckhand loosened the mooring line and readjusted its length before refastening it once the Master repositioned the vessel.

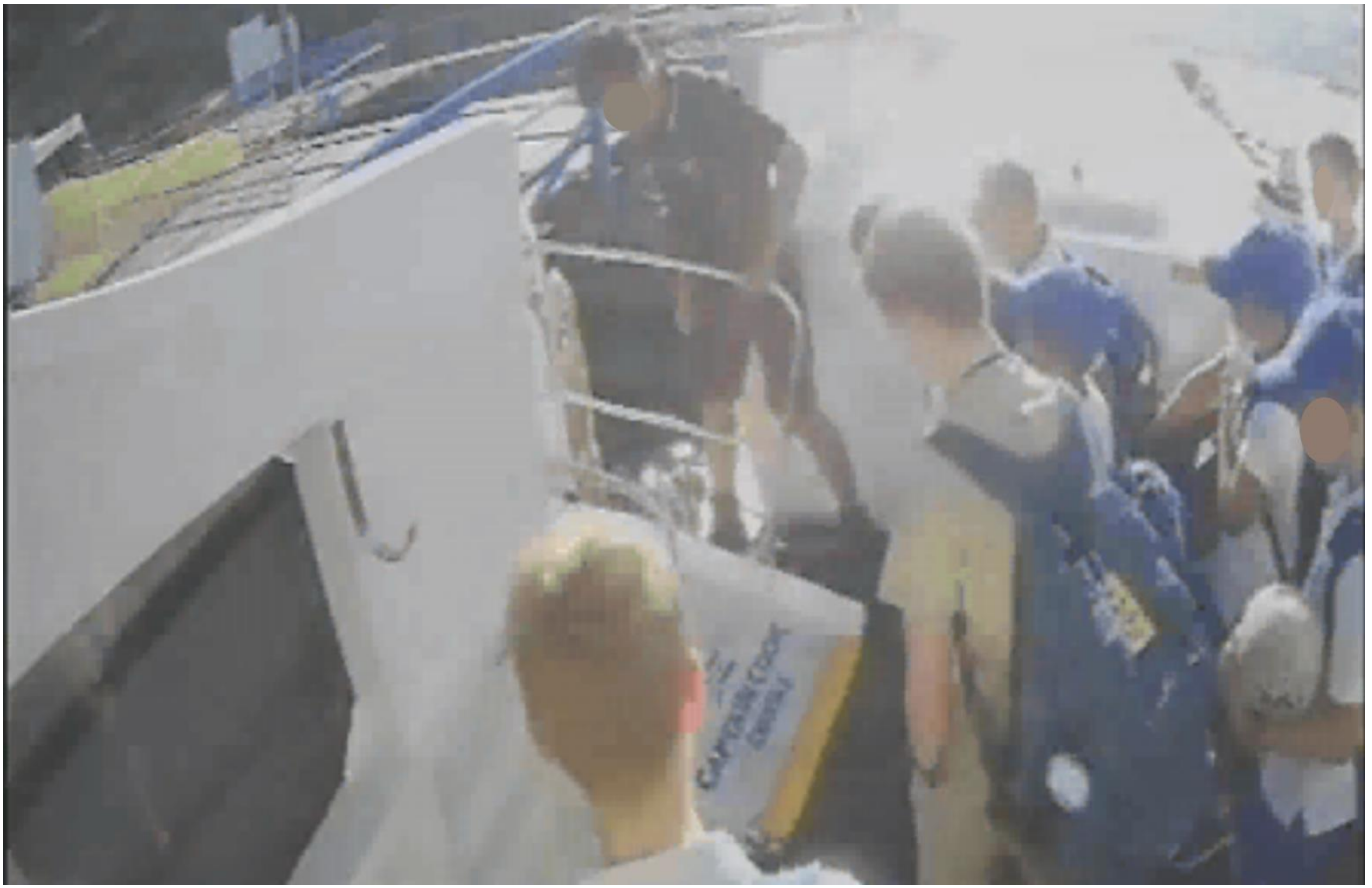
Figure 4: Onboard forward deck CCTV showing students crowding around the gangway at 0811:29

- 1.10 At 0811:29, the Deckhand secured the mooring line and deployed the gangway⁶ onto the western platform (Figure 4). The chain on the gangway was not secured to the vessel as was documented practice. Students quickly moved forward from the foredeck, as a group, to disembark.
- 1.11 During disembarkation, students crowded onto the gangway closely behind each other, with up to five students on the gangway at one time. The students crossed the gangway in a continuous flow, at times in pairs side by side, carrying a school backpack over their shoulders, and often with an accompanying sports bag and/or sporting equipment.

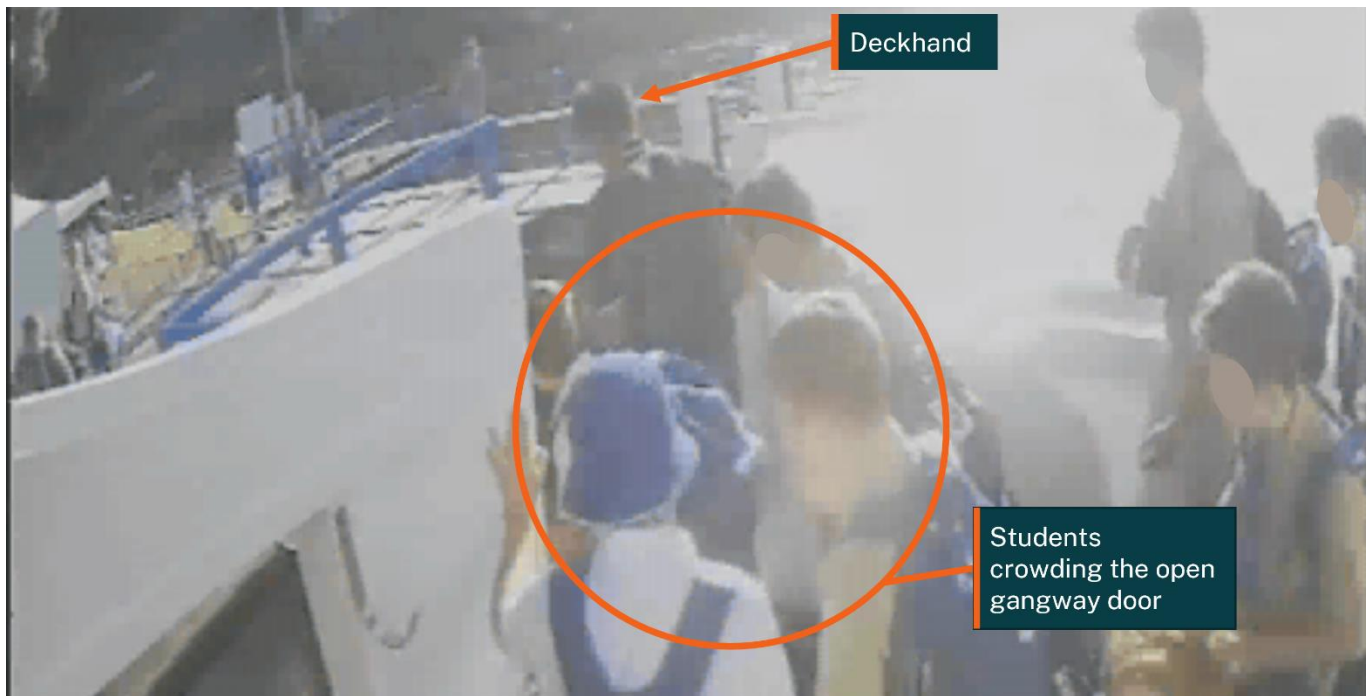
Figure 7: Onboard forward deck CCTV showing students crowding into open door at 0811:51

- 1.16 As the propellor wash pushed the students and gangway towards the narrow gap, student 18, moved through one of the handrails and climbed up onto the upturned gangway. Student 16 remained under the gangway, reporting that they struggled to free themselves from their backpack, with straps over both their shoulders and caught in the gangway handrails.
- 1.17 As the two students were washed forward, away from the vessel, the Deckhand stood in the open doorway, surrounded by a group of students trying to see what was happening in the water (Figure 7). At 0811:53, the Deckhand signalled the Master, pointing out the direction of the students in the water.

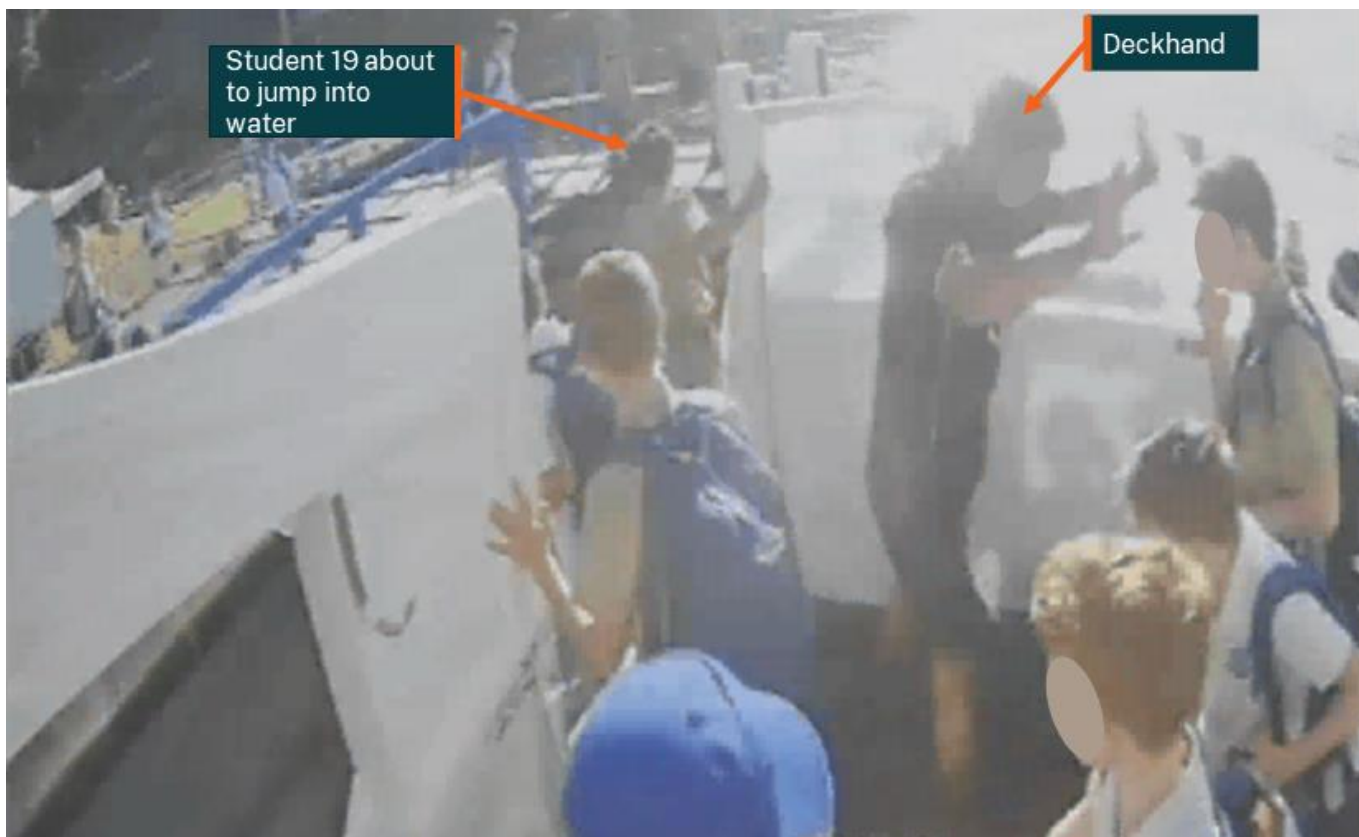
Figure 8: Onboard forward deck CCTV showing the Deckhand motioning for students to clear the area at 0811:57

1.18 At 0811:55, the Deckhand turned around and stepped away from the door to retrieve the Person Overboard (POB) ladder. At that time, a student (Student 19), whose sibling fell into the water, moved past the Deckhand into the open doorway. At 0811:57, the Deckhand motioned for students to clear the area (Figure 8).

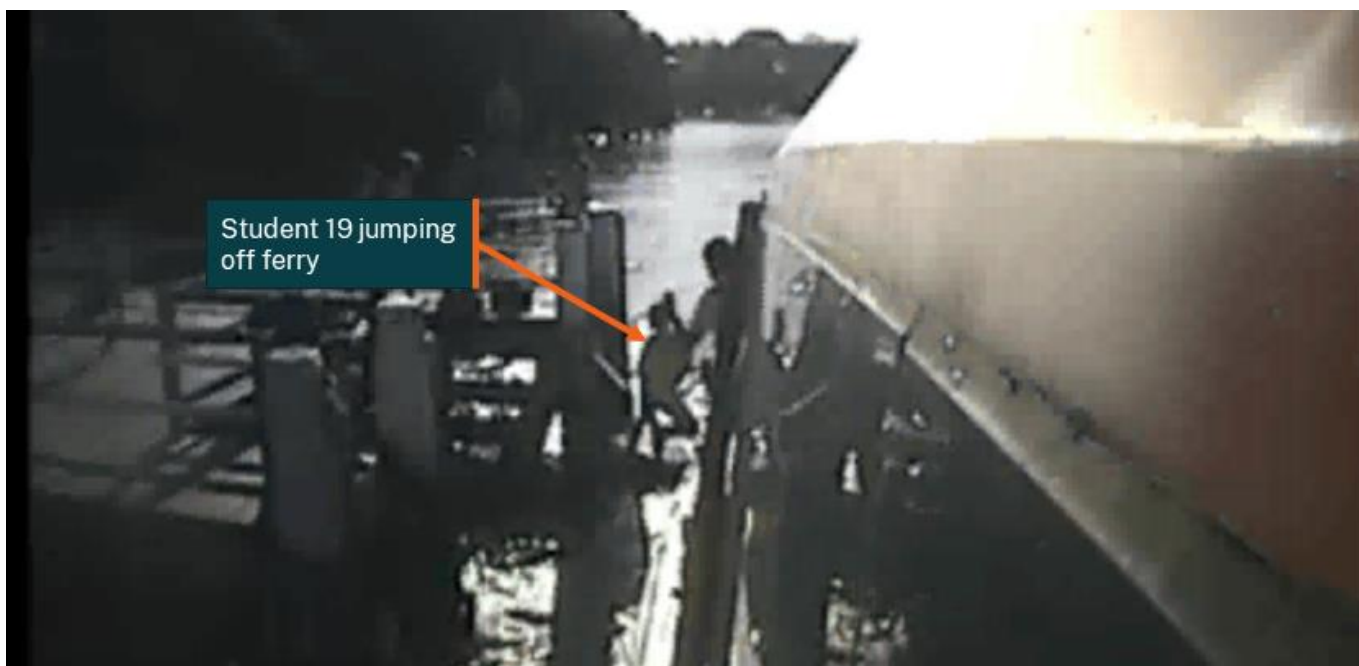
Figure 9: Onboard portside CCTV showing a student jumping into water from unattended door at 0811:57

1.19 When the Deckhand moved from the open doorway, Student 19 jumped into the water, between the ferry and wharf (Figure 9).

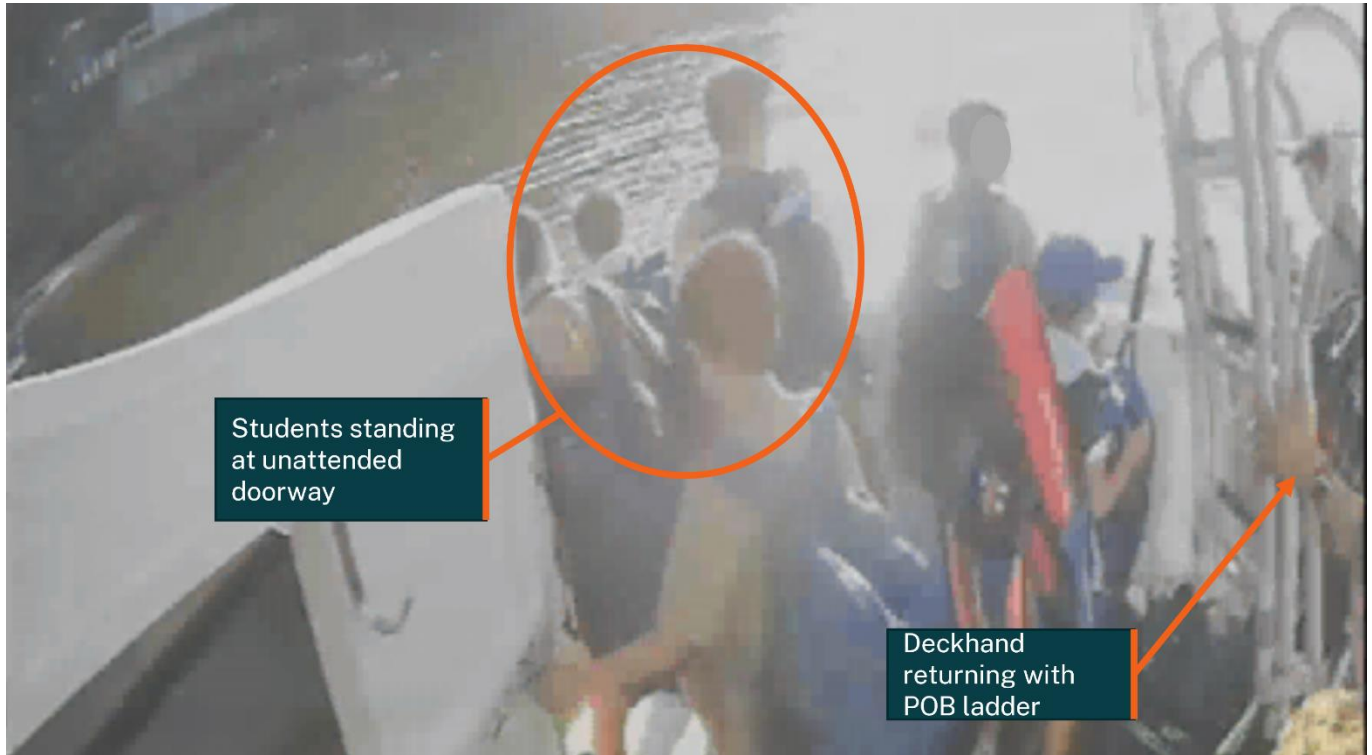
Figure 10: Onboard portside CCTV screenshot showing the Deckhand returning with POB ladder at 0812:19

1.20 While the Deckhand was retrieving the POB ladder, the open door was unattended. Six students crowded into the opening to see what was happening in the water. At 0812:19, the Deckhand returned carrying the POB ladder (Figure 10). The Deckhand again instructed students to move away from the area, which they did, allowing the Deckhand to set the ladder in position.

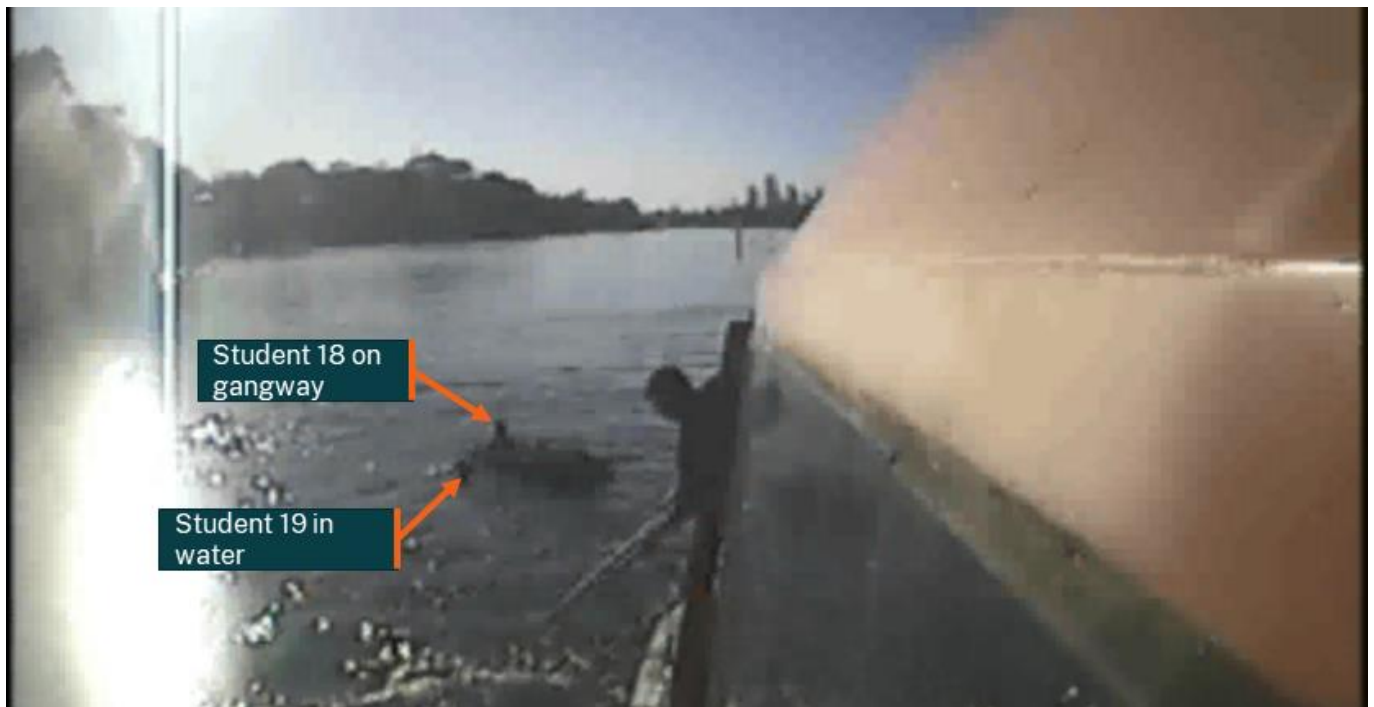
Figure 11: Onboard portside CCTV showing the vessel manoeuvring towards students and gangway at 0812:33

- 1.21 At 0812:28, the Master manoeuvred the vessel away from the wharf and towards the three students in the water, who had drifted downstream to the east. The movement of the vessel away from the wharf caused the attached mooring line to break.
- 1.22 At 0812:33, as the Master positioned the vessel towards the students in the water, Student 18 was on the upturned gangway with Student 19 in the water next to it (Figure 11). At that time, Student 16 was reported trapped underneath the gangway, with their backpack, positioned with the straps over their shoulders, lodged between the submerged gangway handrails. Student 19 swam underwater to free Student 16 from under the gangway, reported to have taken several attempts. Student 16 subsequently surfaced free of the gangway, with the assistance of Student 19.

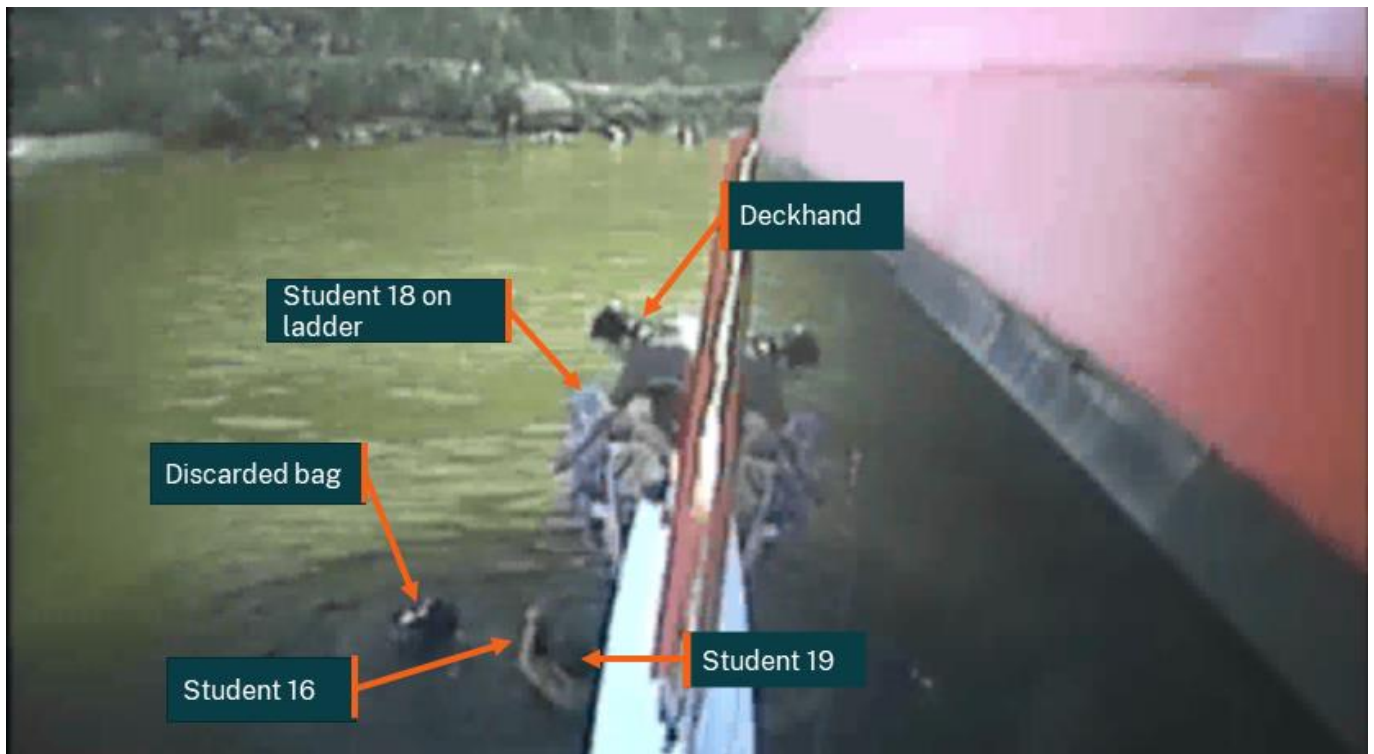
Figure 12: Onboard portside CCTV showing students climbing the ladder at 0813:45

- 1.23 At 0812:43 the Deckhand finished setting the POB ladder and began to give bearings to the Master for the position of the students in the water, via hand signals. The Master manoeuvred the vessel to the students' position.
- 1.24 At 0812:53, the vessel overshot the students in the water. The Deckhand again used hand signals to direct the Master back towards the three students. At 0813:15, the students were close to the base of the ladder when the Deckhand left the doorway to get a life ring, which was deployed at 0813:23.
- 1.25 At 0813:41, all three students swam to the base of the ladder and began to climb up onto the vessel. Student 18 went first, after discarding their backpack which had become waterlogged, impeding their climb (Figure 12).

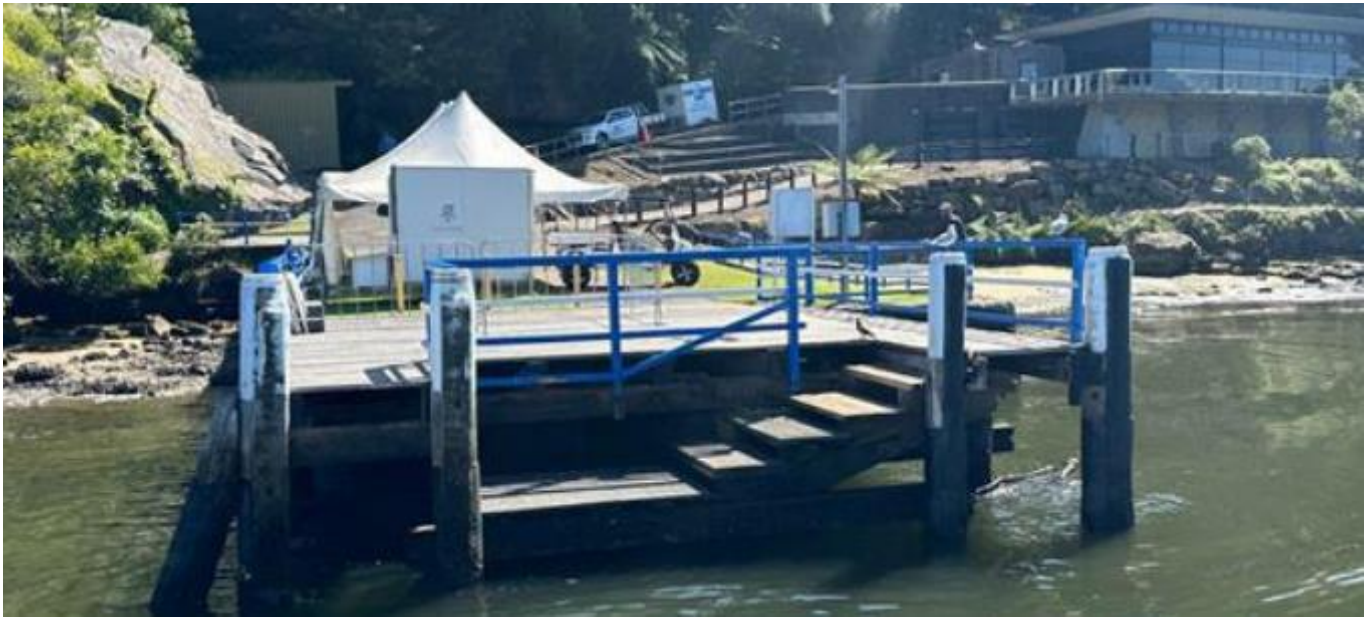
Figure 18: Riverview College Wharf profile at low tide

1.42 There were four wooden steps, the first approximately 450 mm wide with the remaining three 670 mm wide, leading down to a wooden landing that was approximately 2 m wide (Figure 18). The landing and lower two steps were covered with a Fibre Reinforced Plastic nonslip surface. The steps and lower landing were utilised by ferry crew during lower tidal periods when transferring passengers to and from the vessel. At the time of the incident, the wharf had no nonslip paint, edge markings, person overboard retrieval ladder or lighting at the wharf face.
