**Special Commission of Inquiry Into the
Glenbrook Rail Accident**

Interim Report

June 2000

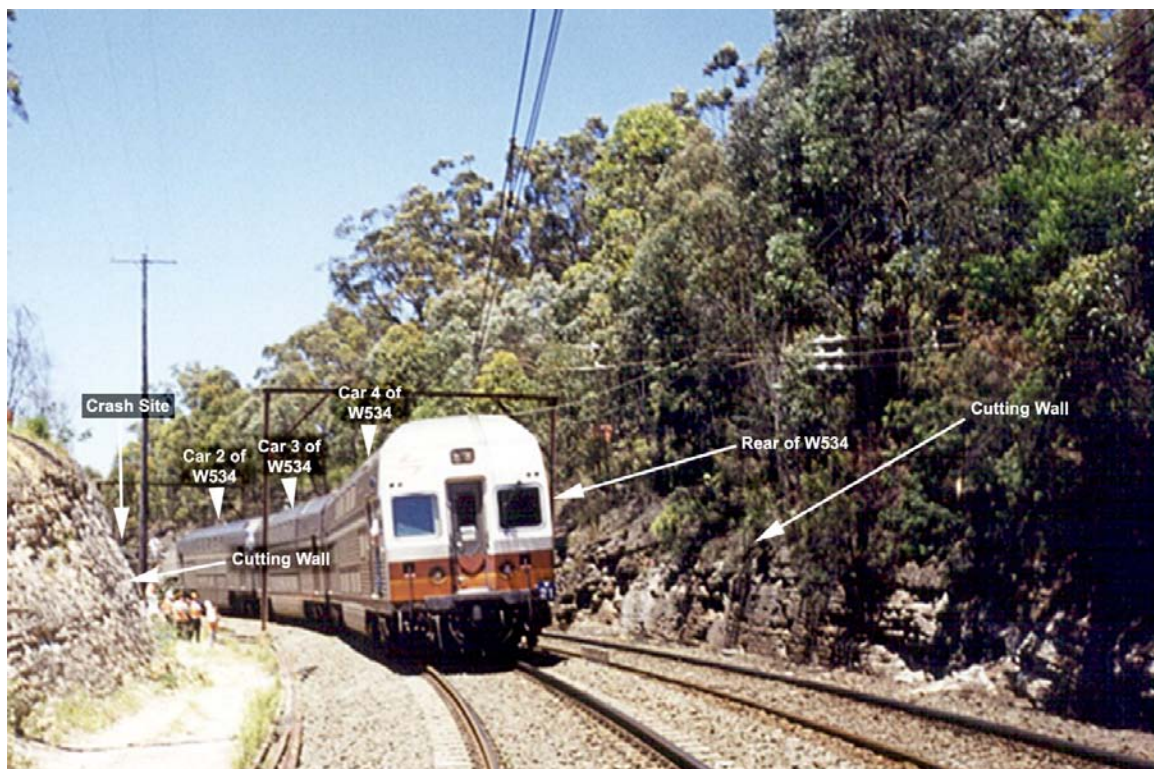
Figure 1 - Rear of the inter urban after collision

The rear wagon on the Indian Pacific was a car carrier wagon called a “motorail”, which penetrated the leading carriage of the inter urban train for a distance of approximately 7.5 metres.

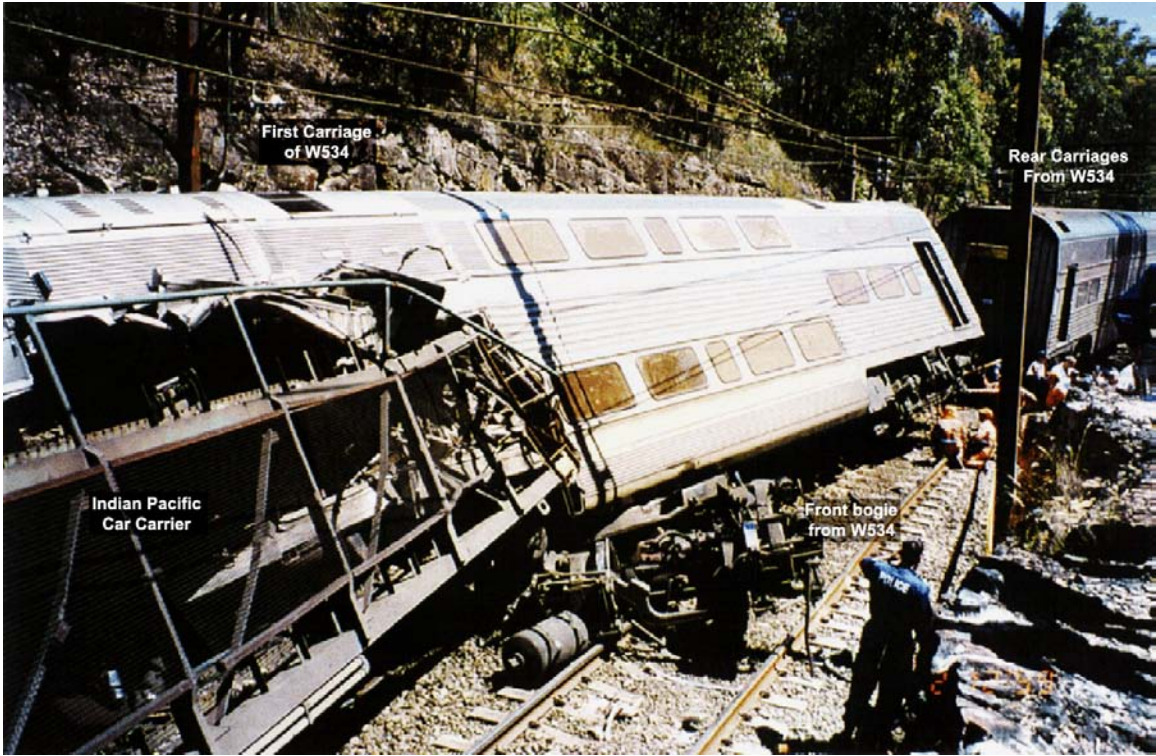
Figure 2 - View of Impact Point

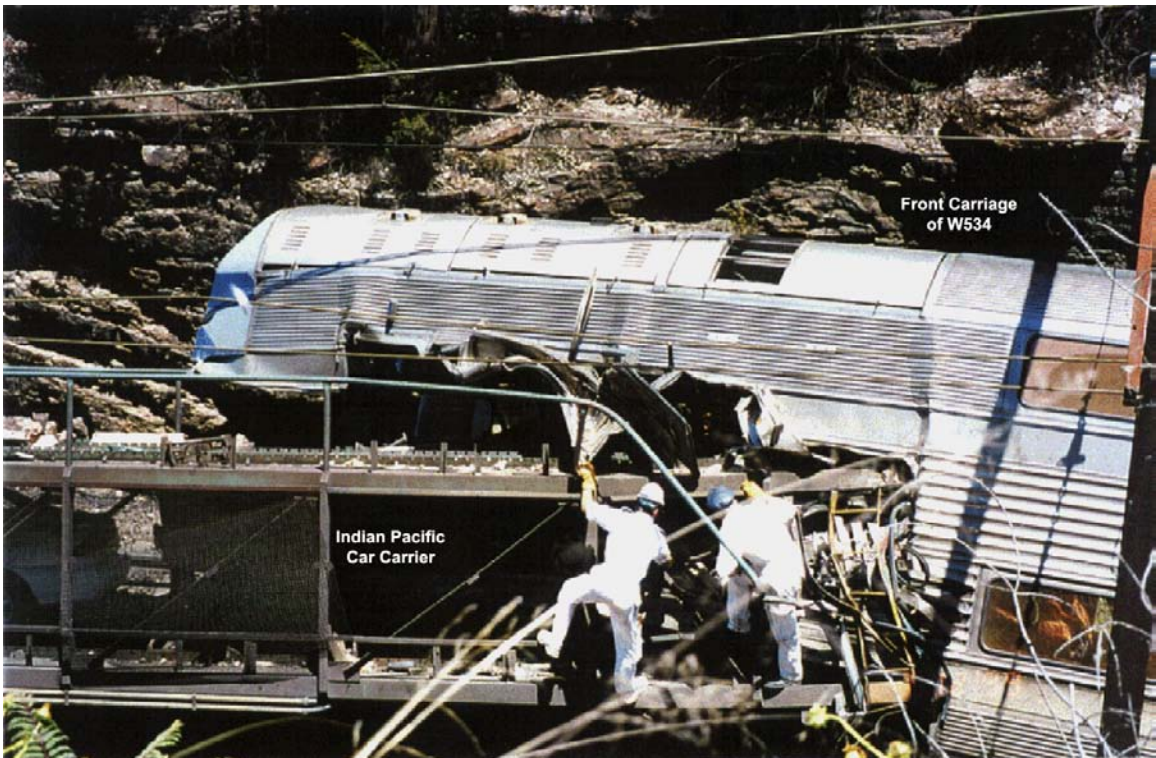
Figure 3 - Side View of Impact Point

There were seven passengers and the driver in that section of the train. All seven passengers were killed instantly. The driver of the train avoided serious injury as he managed to flee the driving compartment and ran through part of the first carriage when a collision appeared imminent.

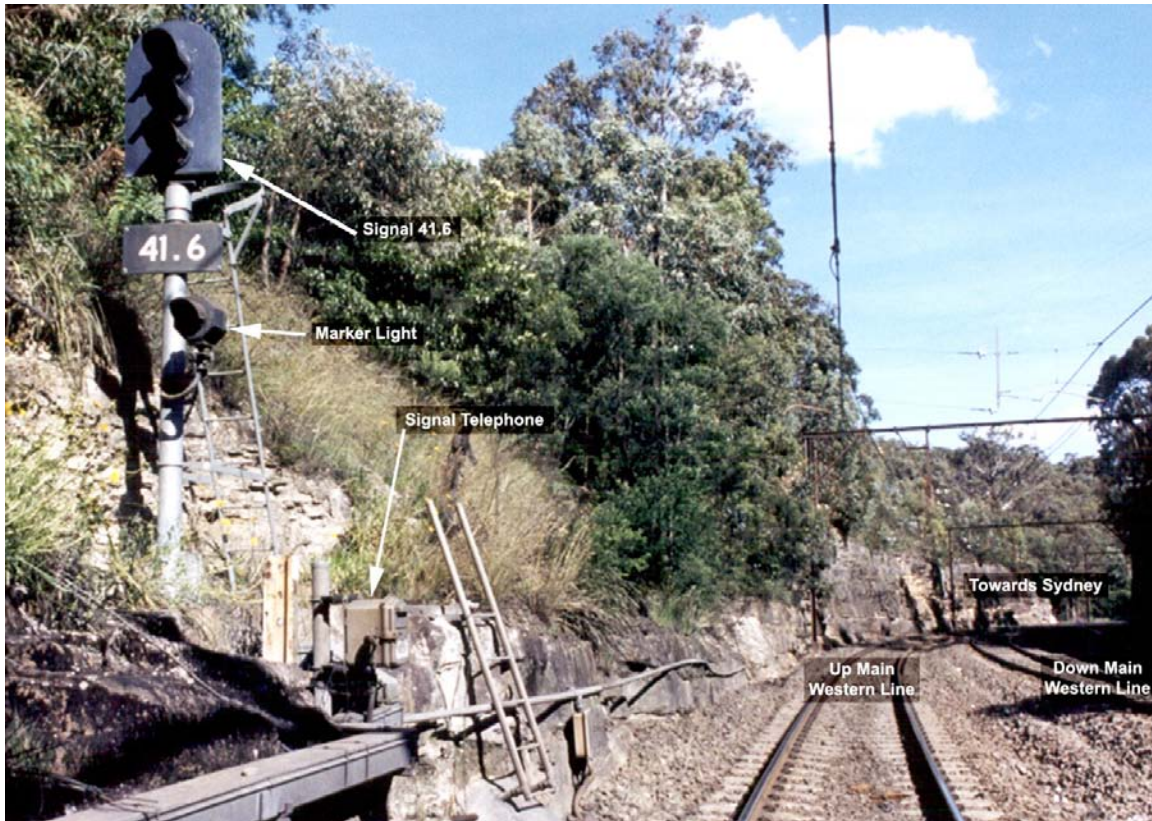
Figure 11 - View of Signal 41.6 showing position of marker light and signal telephone

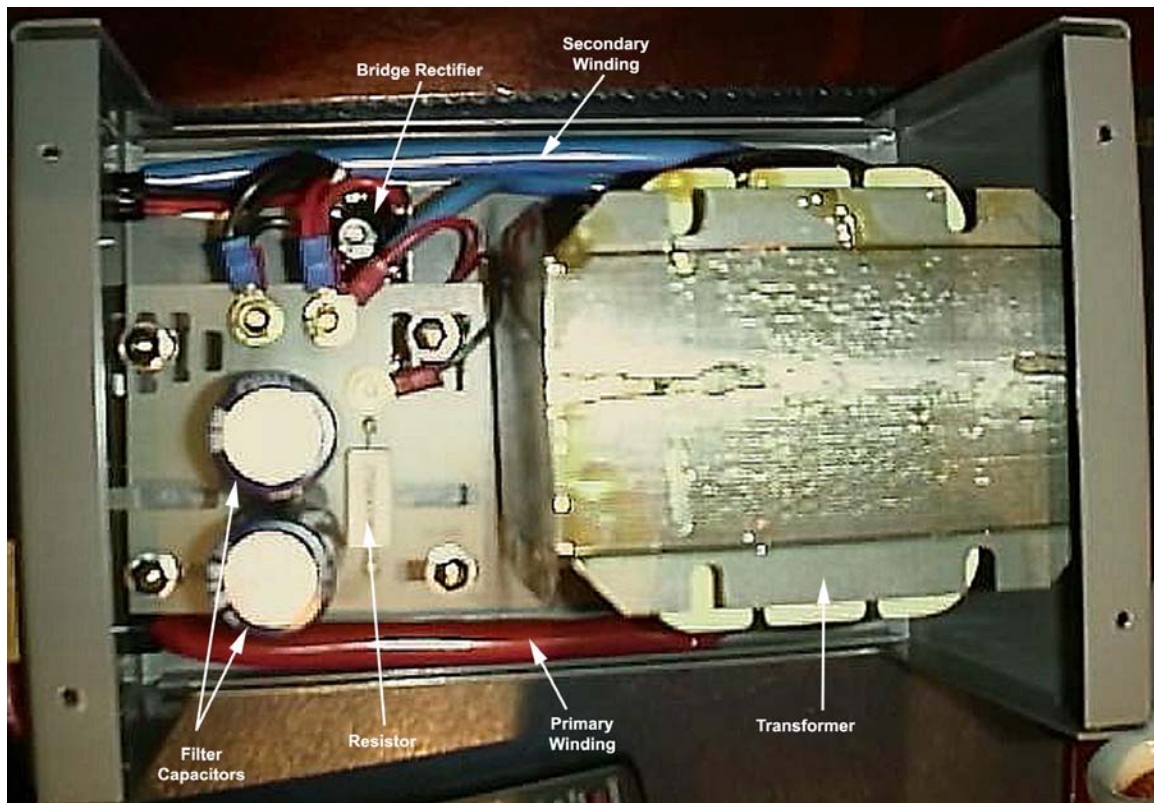
Figure 13 - Power Supply Unit similar to that which failed at Glenbrook

The reason that both signals 40.8 and 41.6 turned to red was that a fuse blew, which disconnected the supply of electricity to a track circuit for signal 40.8, which was also the overlap circuit for signal 41.6. Whilst that fault continued, the signals affected remained at stop even though there was no train in the section or any obstruction on the track. The fuse blew because a diode, which formed part of a bridge rectifier in a power supply unit, failed and the electrical circuit began to draw current in excess of the rating of the fuse causing it to blow. One of the functions of the power supply unit is to reduce the normal 240 volts supply to 120 volts, at the same time converting it from alternating current (AC) to direct current (DC). It is the bridge rectifier which performs the latter function. There are four diodes in the bridge rectifier.

It has not been possible to establish why the failure of the diode occurred during that particular five minute period. Mr Szacsvey, a senior engineer with Rail Services Australia, investigated the cause of the failure, and was of the opinion that the relevant power supply boxes were properly maintained. He said the component that failed was a completely enclosed unit which was usually very reliable. Furthermore, there was no means of inspection to determine if the bridge rectifier, which was part of a sealed unit, or any part of it was likely to fail. Mr Szacsvey postulated that lightning activity some ten days before the accident may have caused a weakening of the component leading to the failure some days later.

There is no evidence that the failure occurred because of a lack of maintenance or that the failure could have been anticipated. Furthermore, the component having failed, the signals operated as they were designed to do by going to stop. The only way it could be established that there was a signal failure was an investigation involving the removal and testing of the components, as was carried out by Mr Szacsvey several days after the accident. Even if this had been done shortly before the failure it would not have detected that a failure was about to occur. Although it was suggested that there could have been a back up power supply system this would have meant duplication to protect the circuitry against the possibility of an extremely rare failure in an otherwise reliable system. Such cost would not have been justifiable.

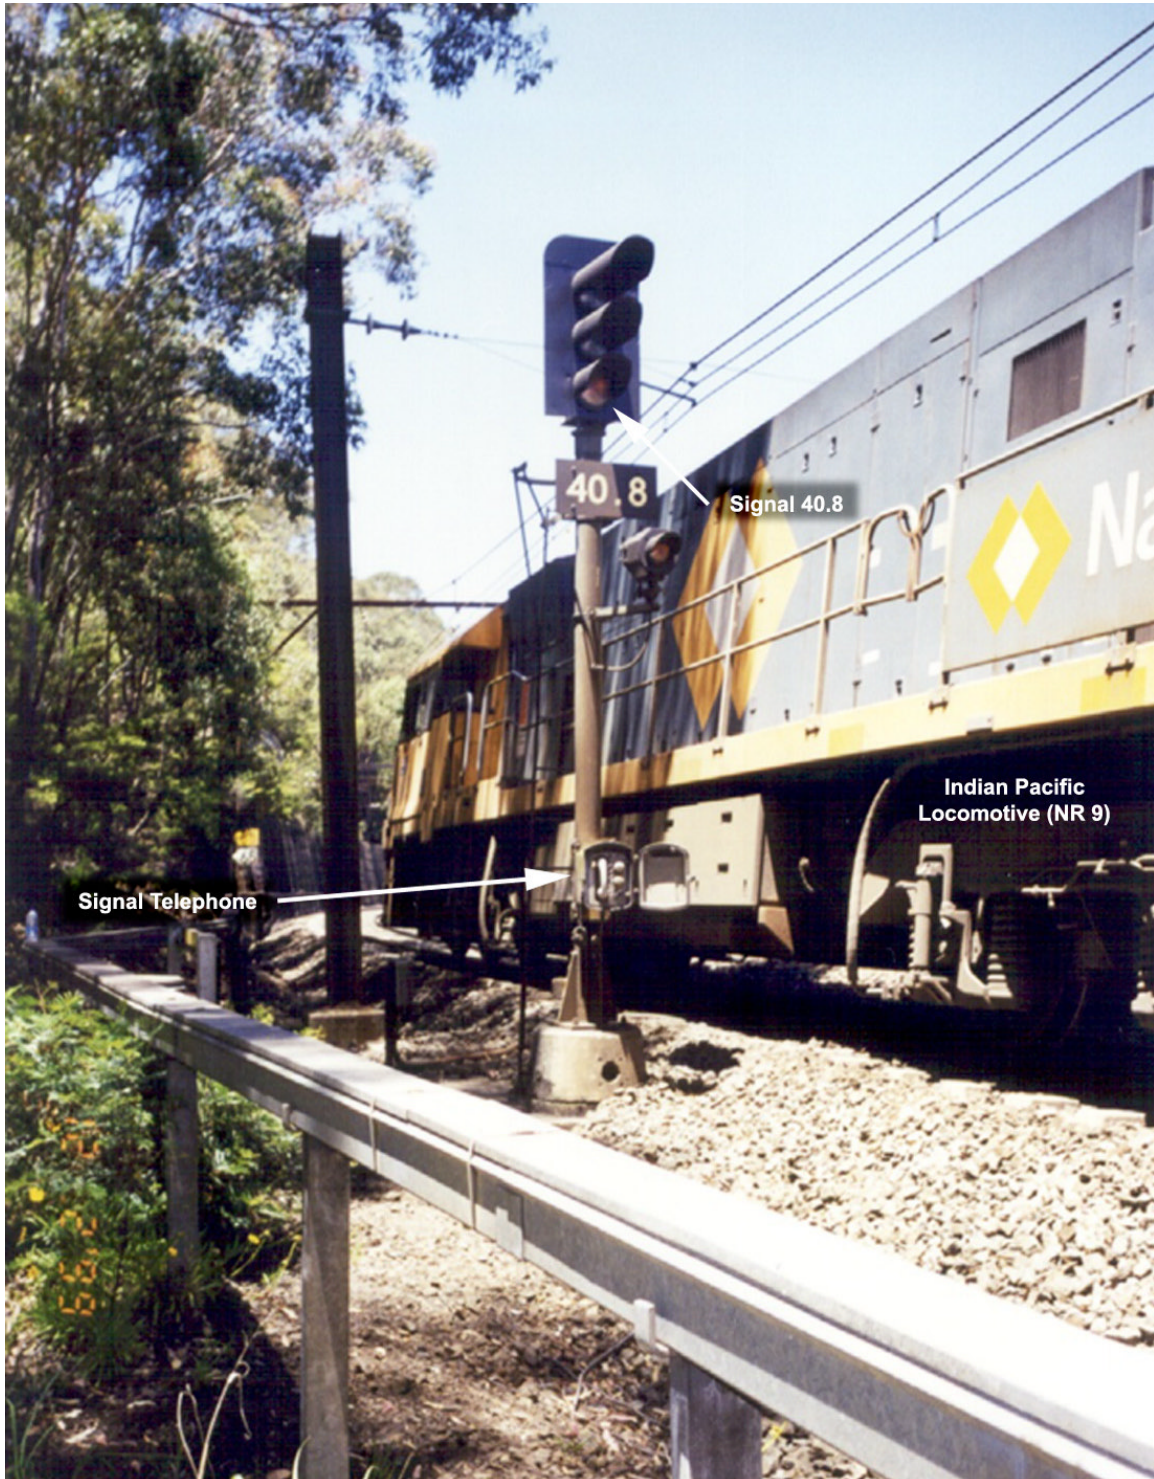
When the Indian Pacific arrived at signal 40.8, which was in the stop position, the train was stopped by Mr Marshall and Mr Willoughby left the locomotive with the intention of contacting the Penrith signal box. Mr Willoughby, on arriving at the signal telephone, saw that the lock and chain securing the telephone had been broken.

Figure 17 - The Indian Pacific at signal telephone 40.8 after the accident

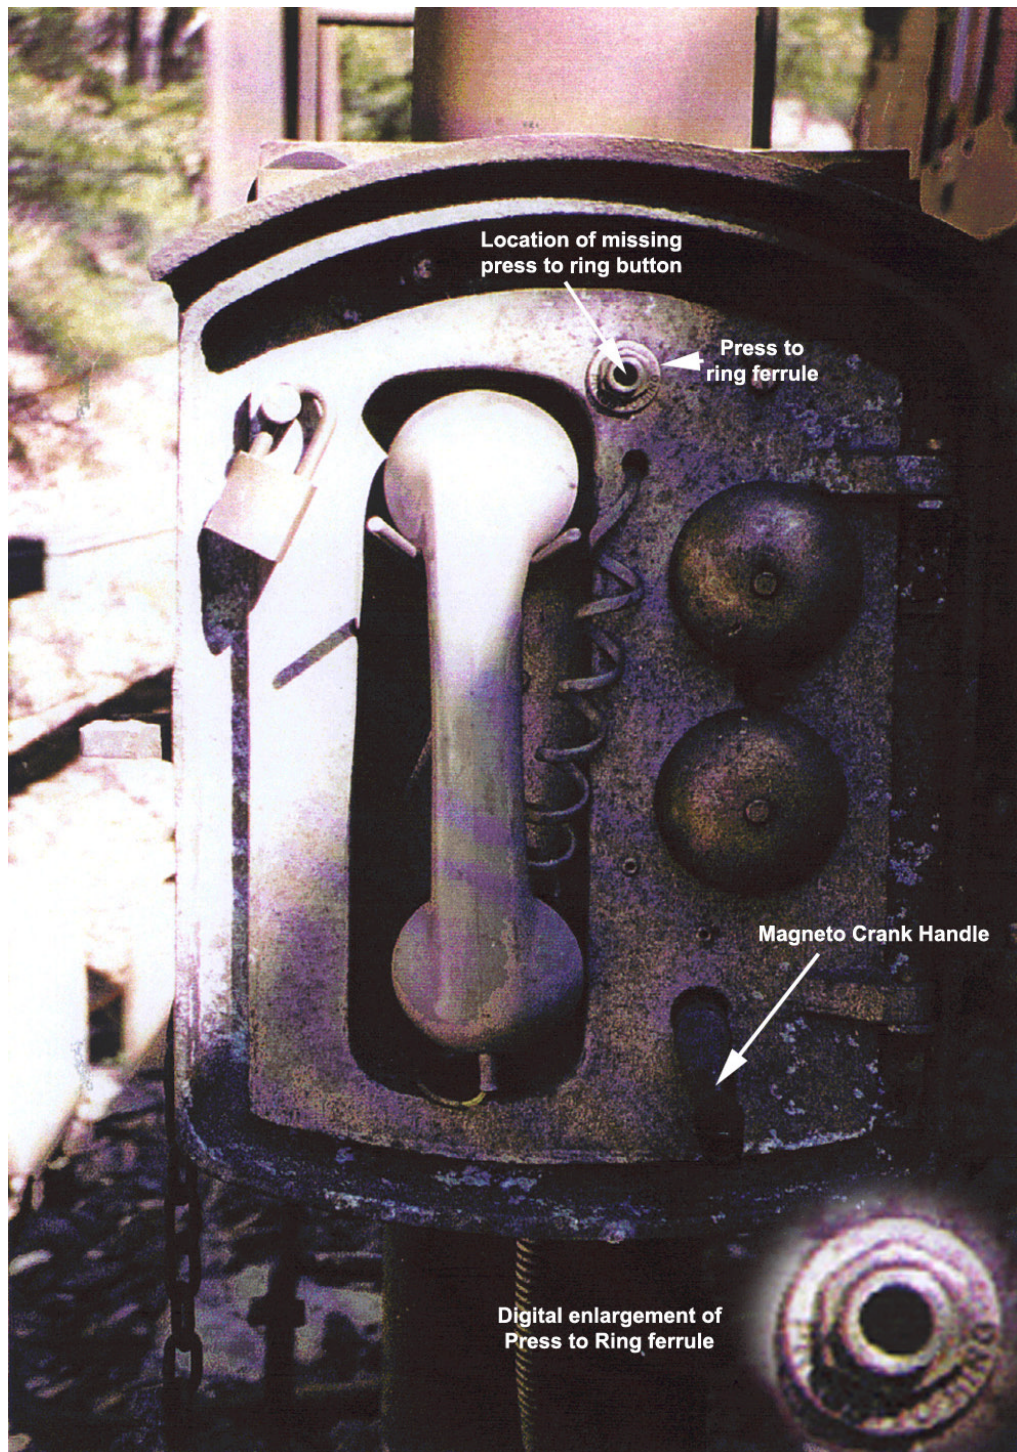
He picked up the handset to see if anyone was on the line and there was no one on the line. He then went to press the “push to ring” button and it was missing from the housing. He attempted to call Penrith signal box by turning the crank handle five to ten times. He did not get any response from the Penrith signaller but he “could distinguish that there were voices in the background as if there was a receiver on a table and there was someone on the other end of the phone and there was a conversation going on”. He said “I couldn’t understand any of the words in the conversation or if anyone was talking to me.”

Figure 18 - Signal telephone 40.8 on 2 December 1999

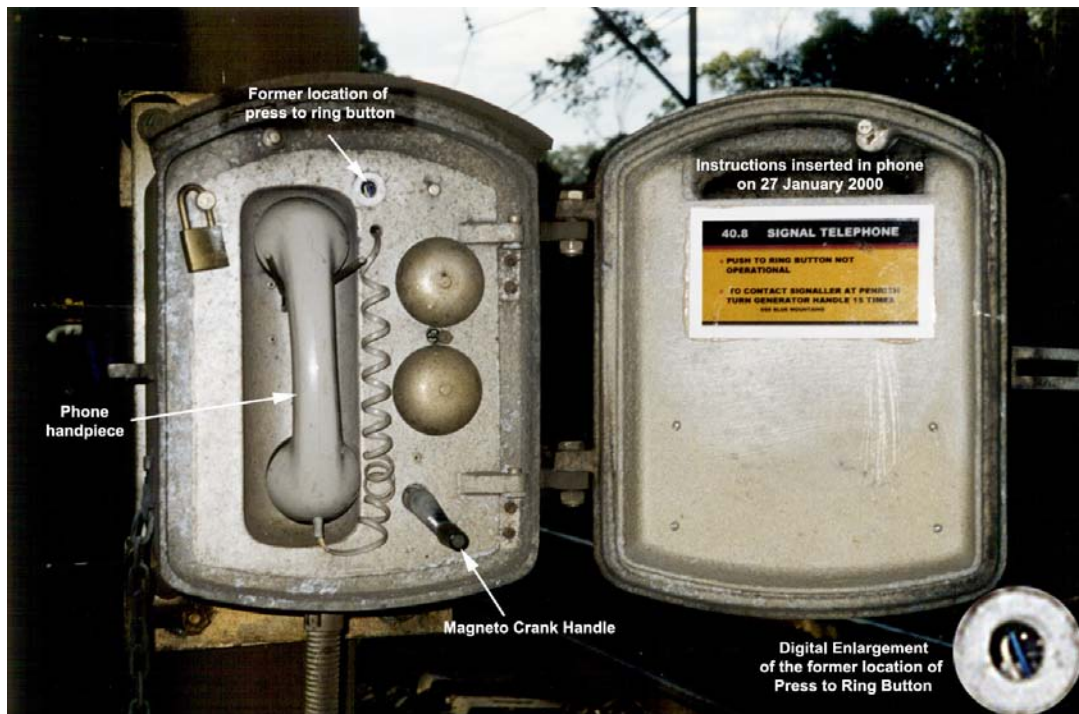
Between Mr Sheather's two tests a decision was made to place a sign on the inside of the casing of signal telephone 40.8. This is the only signal telephone to have such a sign and it was specially produced by Mr Garry Leamey, the District Signals Engineer, Rail Services Australia. It was placed in the signal telephone by Mr Greg Carty, Signals Electrician, Rail Services Australia, on 27 January 2000.

Mr Leamey stated that the words contained on the sign were his. He was asked why he chose to include an instruction to turn the handle 15 times and replied that this was done because it was his personal practice when operating such a telephone to turn the handle 15 times. He stated that the sign was installed to prevent any confusion about the operation of the telephone.

Figure 20 - Signal telephone 40.8 in February 2000
