Ferry Safety Investigation Report

Children overboard at Riverview College Ferry Wharf,
Riverview, NSW, 16 February 2023

Investigation Reference IO2038

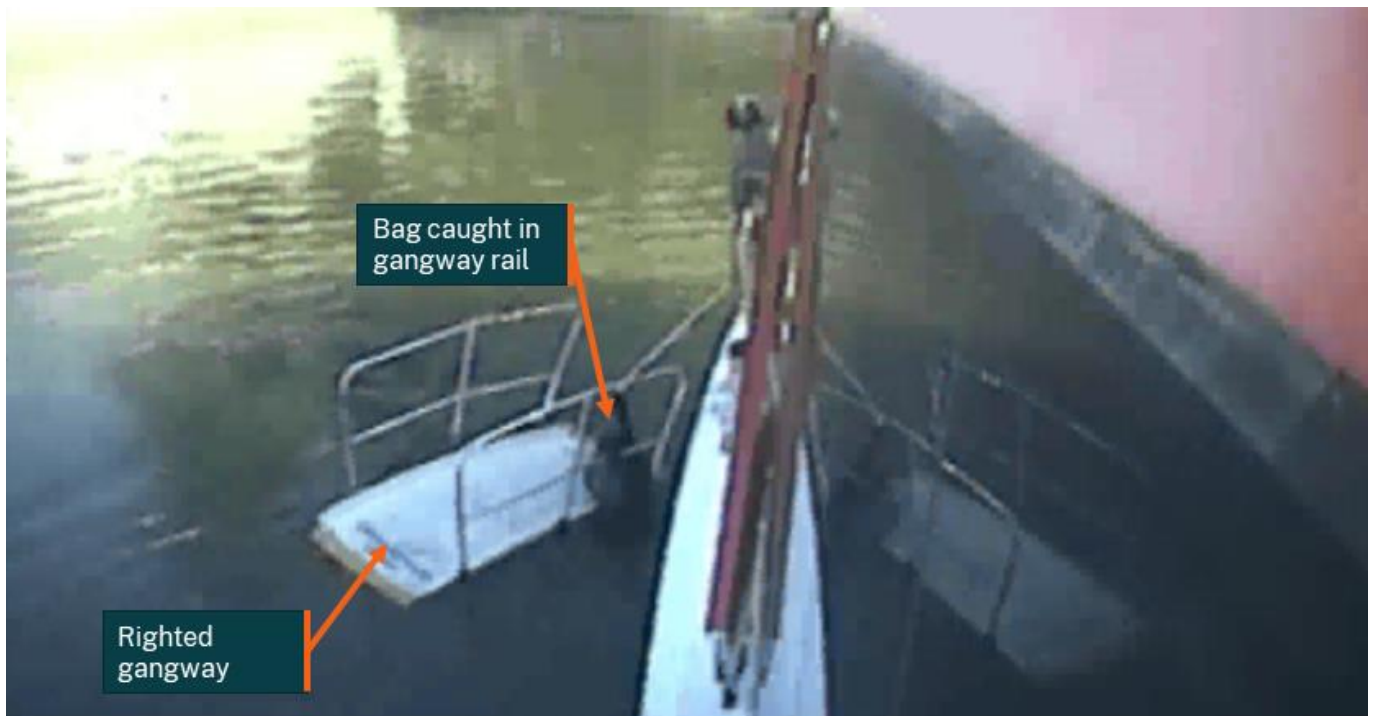
1.27 Following recovery of the three students, the Master manoeuvred the ferry to retrieve the floating gangway. The Deckhand righted the gangway in the water which had a backpack wedged between the gangway handrails. Recovery of the gangway and bag was then carried out by the Deckhand, with the assistance of students onboard. (Figure 13).

Figure 13: Onboard portside CCTV showing recovery of the gangway and backpack at 0815:53

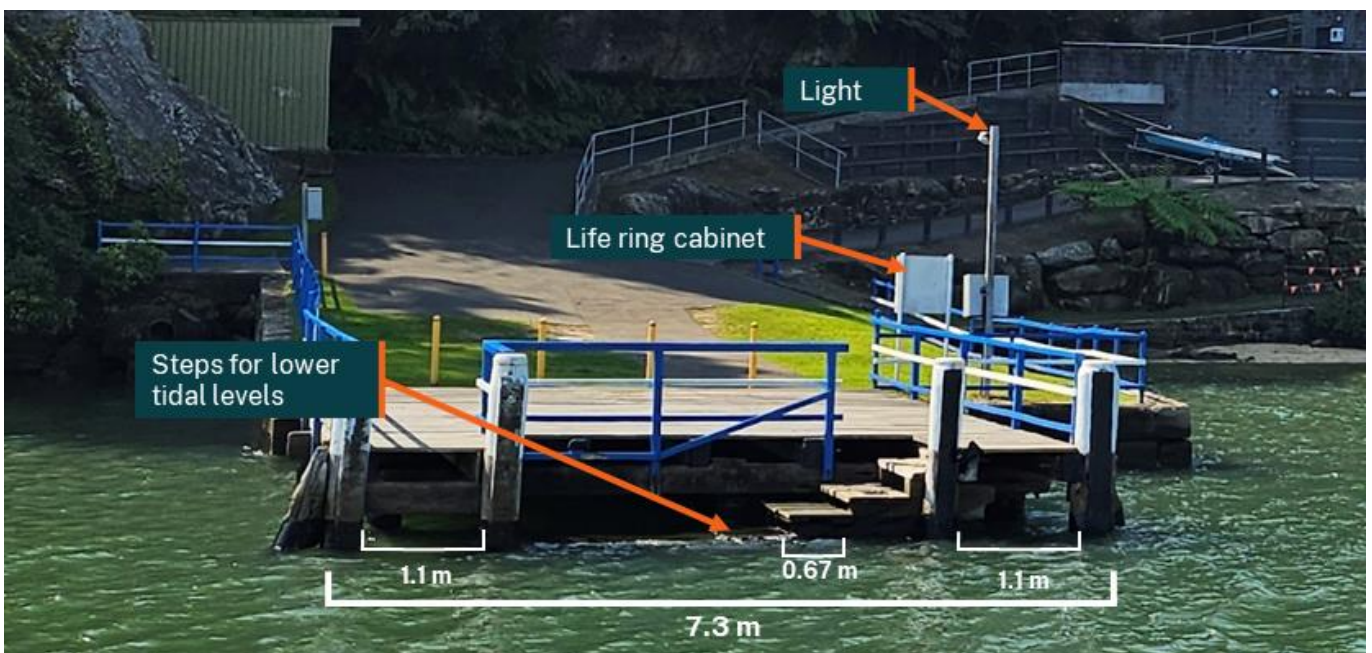
1.41 Riverview College Wharf had two deck level landings of approximately 1.1 m width, located at the Western and Eastern sides of the southern 7.3 m berthing face. The central section of the berthing face included four steps descending to a landing. As there were no mooring cleats or bollards, wharf piles were used to secure vessels. The wharf had a life ring cabinet positioned shoreside on the edge of the rock jetty, and an adjacent overhead light (Figure 17).

Figure 17: Riverview College Wharf viewed from Lane Cove River

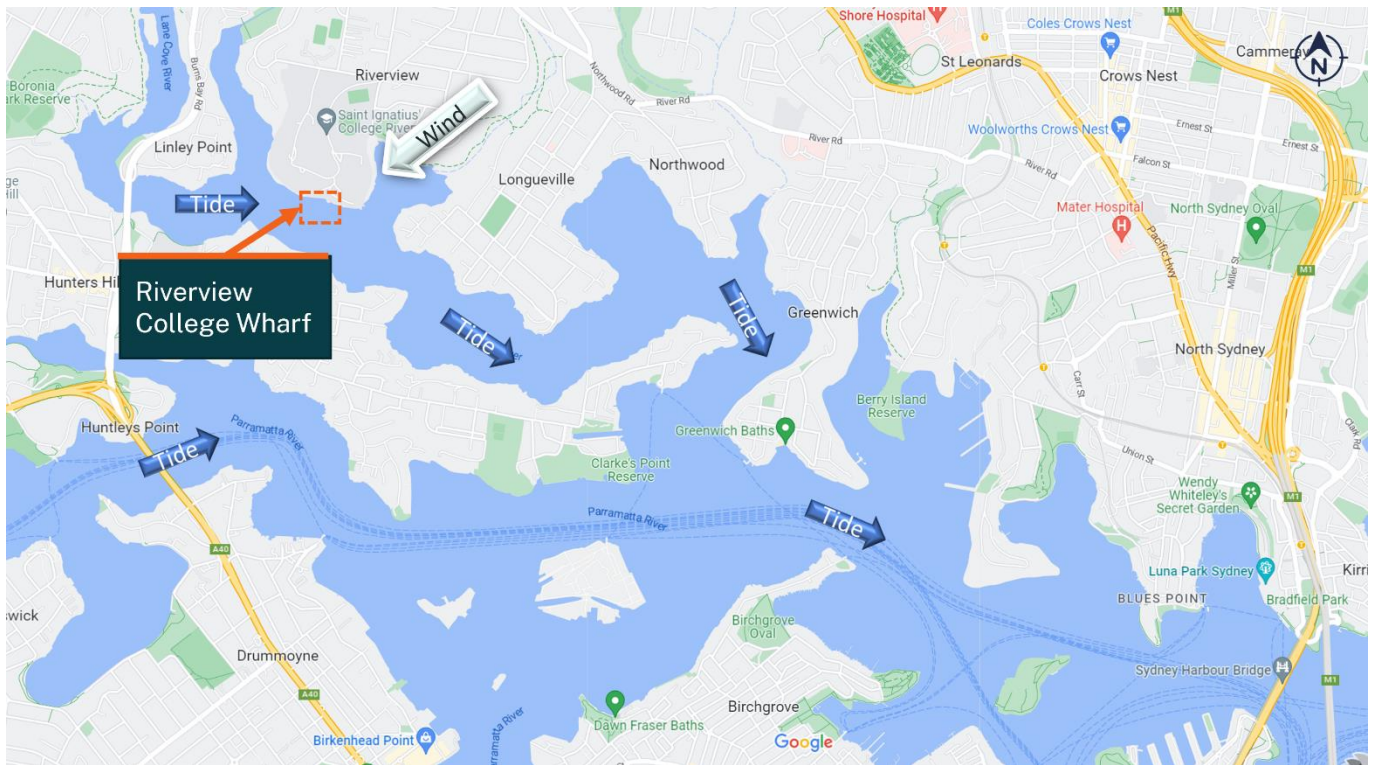
1.44 The tide on the day was a high at 0507 of 1.61 m dropping to a low of 0.48 m at 1209. At the time of the incident the tide was ebbing.⁸ The tidal direction at Riverview College Wharf was from west to east (Figure 19).

Figure 19: Map showing the location of Riverview College Wharf and environmental conditions at time of incident

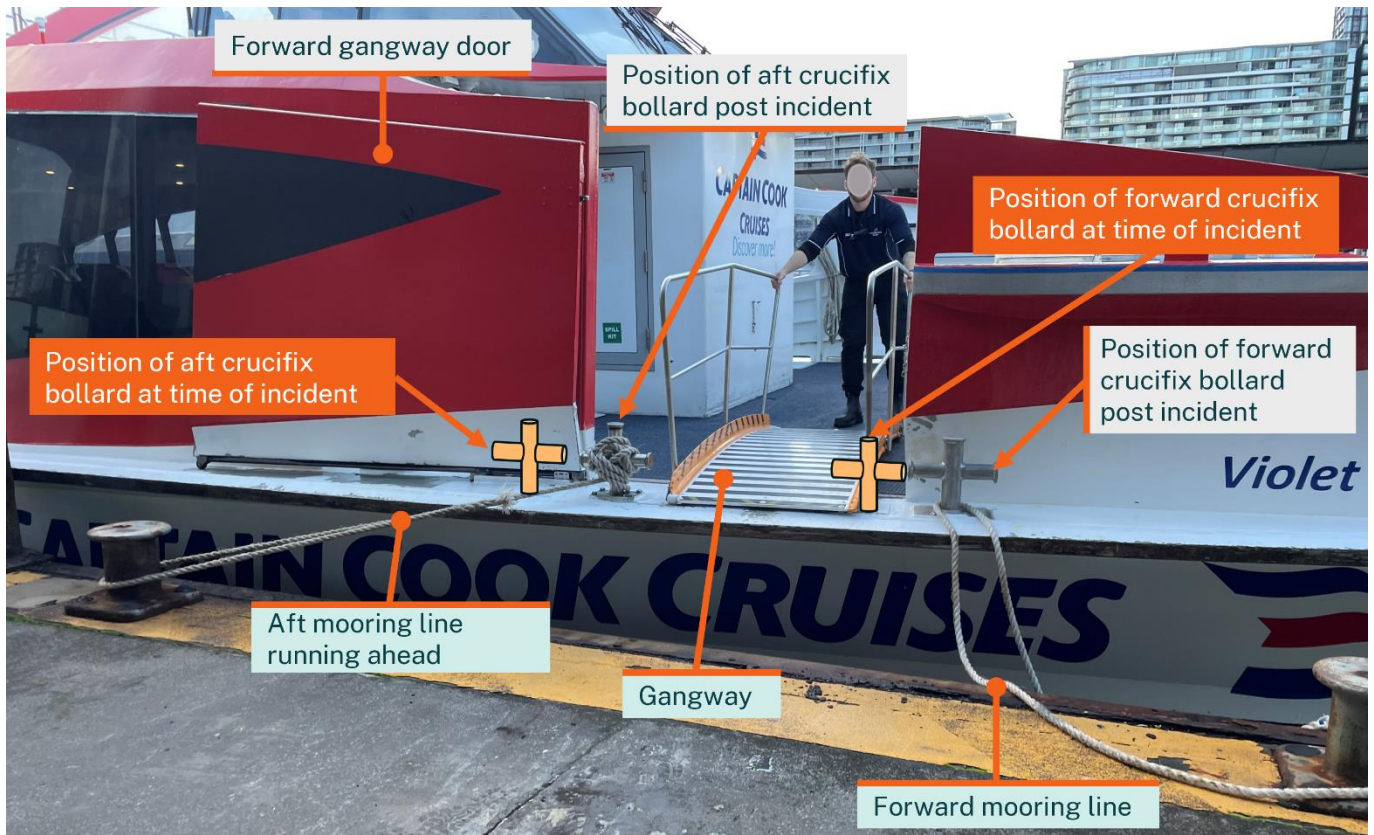
- 1.51 Berthing of *Violet McKenzie* was undertaken through securing mooring lines at the forward or aft crucifix bollards, or both, as necessary. The position of the aft crucifix bollards, at the time of the incident (Figure 22) were close to the open sliding gangway door. It was reported that the proximity of these bollards to the sliding gangway doors made it challenging for a Deckhand to secure a mooring line. This was due to several factors including proximity to the door, and reduced accessibility. In this configuration, it was reportedly easier for a Deckhand to secure a mooring line to the forward crucifix bollard, as it was clear of obstructions and facilitated the vessel berthing running astern.

- 1.52 Post incident, on the 12 May 2023, the positions of the crucifix bollards, at the forward gangway doors, were returned to their 'as built' original configuration (Figure 22). This configuration favoured use of the aft crucifix bollards as they were clear of any obstruction, and therefore was easier to berth the vessel running ahead.

Figure 22: Violet McKenzie crucifix bollard positions on the starboard forward gangway door location

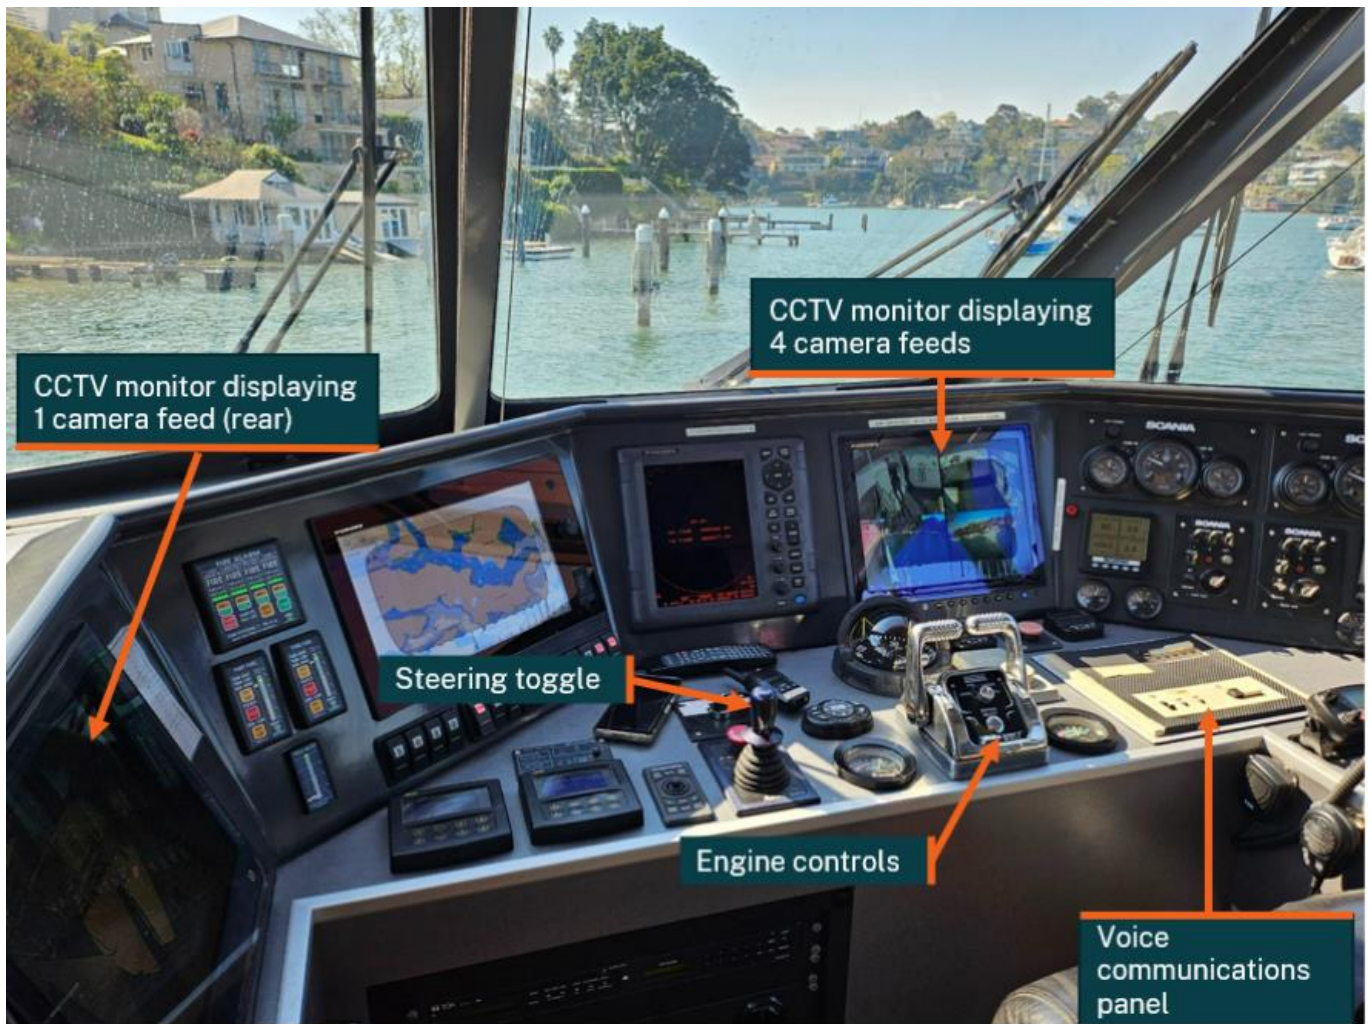
- 1.54 The voice communications panel in the wheelhouse was located adjacent to the engine controls and below a CCTV monitor displaying four onboard camera feeds (Figure 24).
- 1.55 On the Super Rocket Class vessels, there was limited direct visibility from the Master's position in the wheelhouse to view the forward deck and gangway door areas. Due to direct visibility limitations the Super Rocket Class vessels, including *Violet McKenzie*, had several CCTV cameras to assist the Master in monitoring the working deck and sections of the vessel that could not be seen from the wheelhouse position. The cameras streamed images to monitors located in the wheelhouse (Figure 24).

Figure 24: Super Rocket Class wheelhouse layout

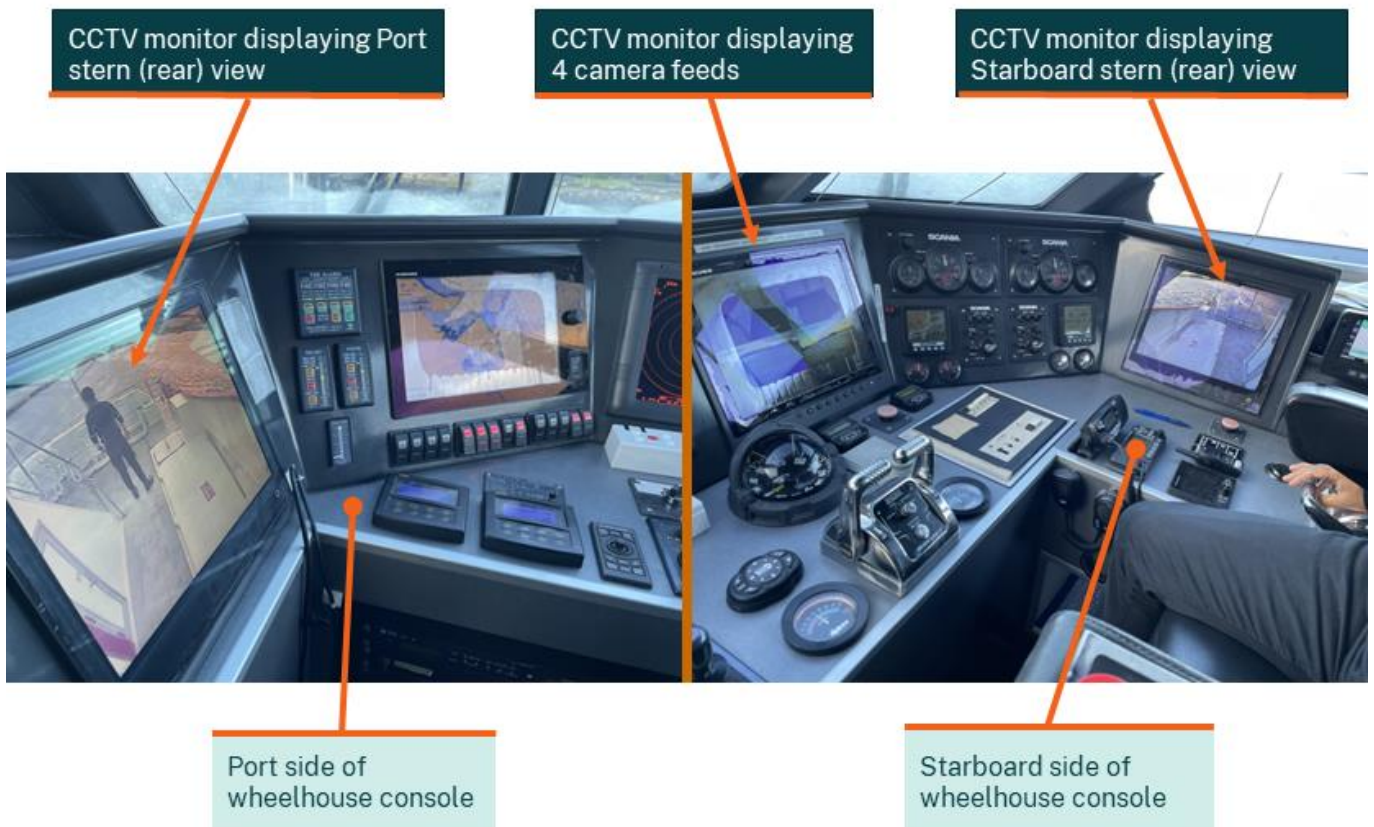
- 1.56 One monitor on Super Rocket Class vessels was usually set to simultaneously display four CCTV camera feeds. A single camera feed could also be displayed full screen. It was reported that the CCTV cameras usually displayed on this monitor were from both port and starboard forward gangway decks, and views towards the stern of the vessel, along either side. These CCTV cameras did not provide a view of the port side of the ferry where it interacted with the wharf. However, that CCTV view was available.
- 1.57 There were also two CCTV monitors located on the port and starboard side of the wheelhouse, these monitors were set to display camera feeds from their respective port and starboard sides of the rear passenger deck (Figure 25).

Figure 25: Port and Starboard side wheelhouse console CCTV monitor layout

- 2.27 Violet McKenzie's CCTV cameras provided limited visibility to the Master. In addition, not all of the CCTV camera streams were shown to the Master on the wheelhouse console monitors. Of note in this incident the default monitor setting did not provide a view of the port side of the vessel where it interacted with the wharf (Figure 3 on page 10). The selection of CCTV camera views to be displayed at the wheelhouse console could be changed using a computer mouse located near the floor of the wheelhouse. That interaction could lead to the detriment of maintaining a proper lookout during a ferry journey or at the time of berthing operations.

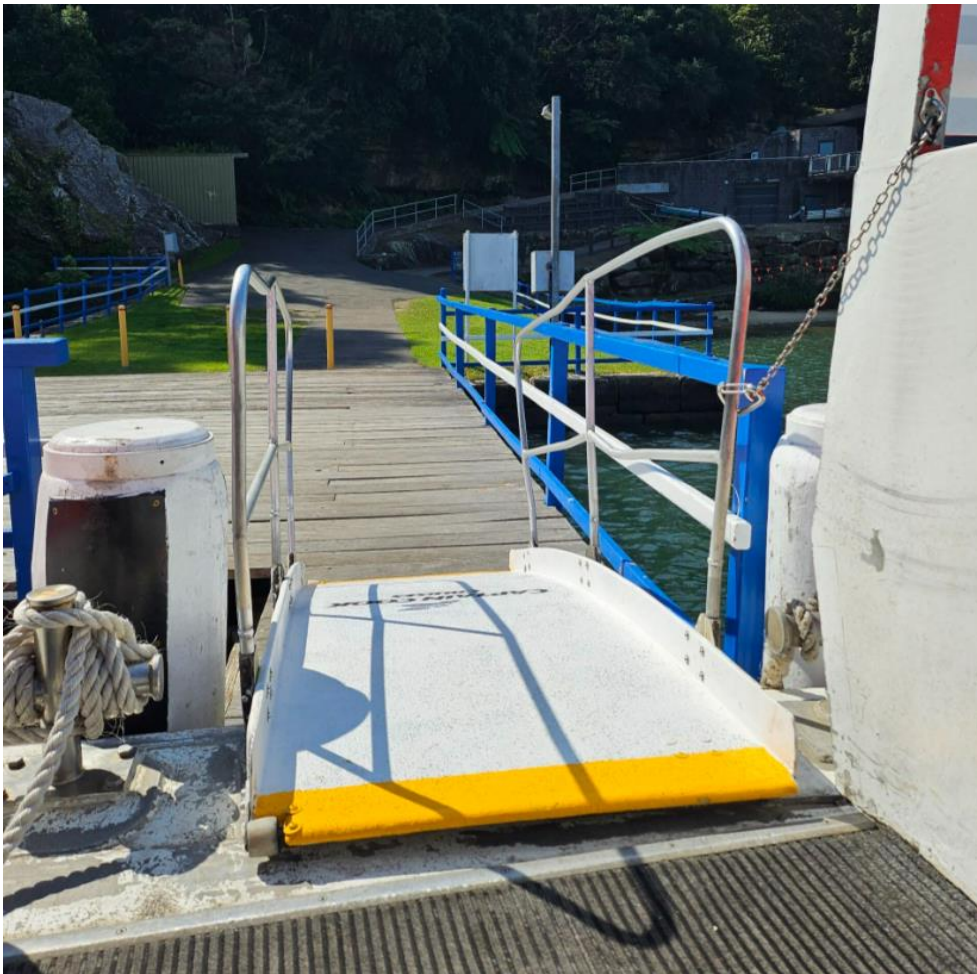
- 1.60 The gangway carried onboard the vessel and used on the Lane Cove River service was 850 mm wide and 2.4 m long. It weighed approximately 25 kg and was constructed of fibreglass, with aluminium handrails.
- 1.61 There was a chain attached to the handrail on one side, to clip the gangway to the vessel when in place for passenger embarkation/disembarkation (Figure 27).

Figure 27: Gangway design involved in incident

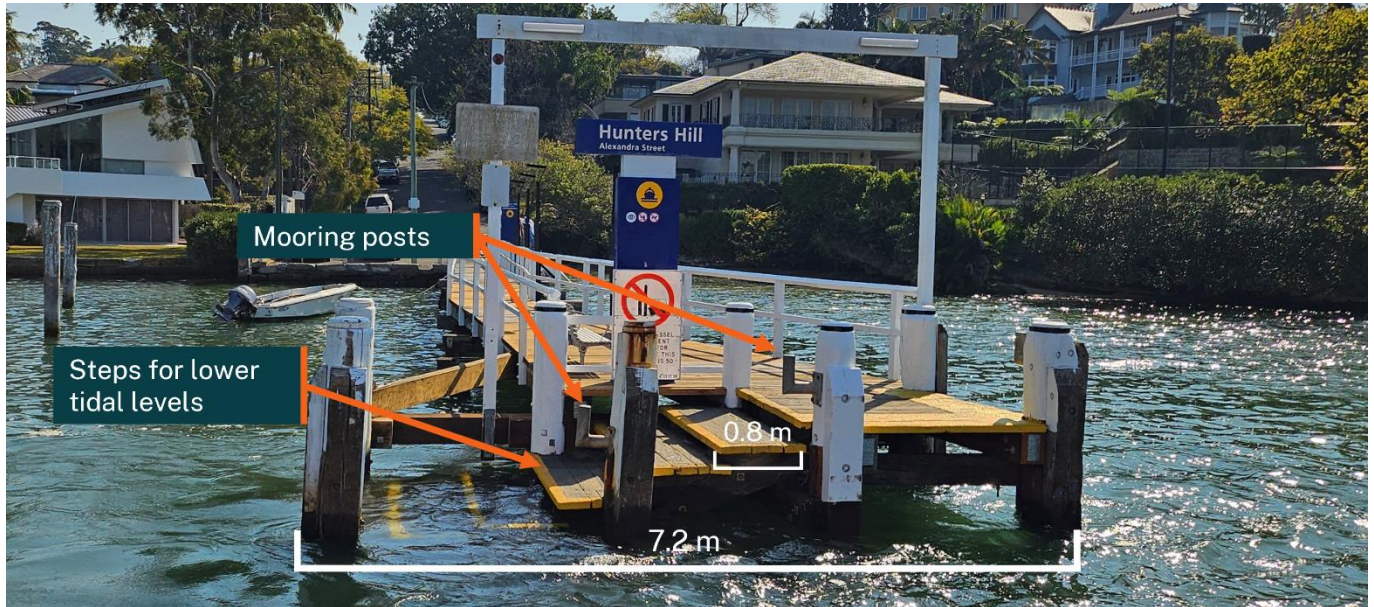
1.163 Hunters Hill Wharf had a berthing face of approximately 7.2 m. Hunters Hill Wharf (Figure 36) included mooring posts³¹ for vessels and had nonslip paint and defined edge markings on the deck and steps.

Figure 36: Hunters Hill Wharf – fixed structure

1.164 Hunters Hill Wharf did not have a recovery ladder for persons in the water to utilise. The 0.8 m depth steps were narrower than the gangways utilised by CCC, this increased the risk of the gangway becoming unstable during operations.

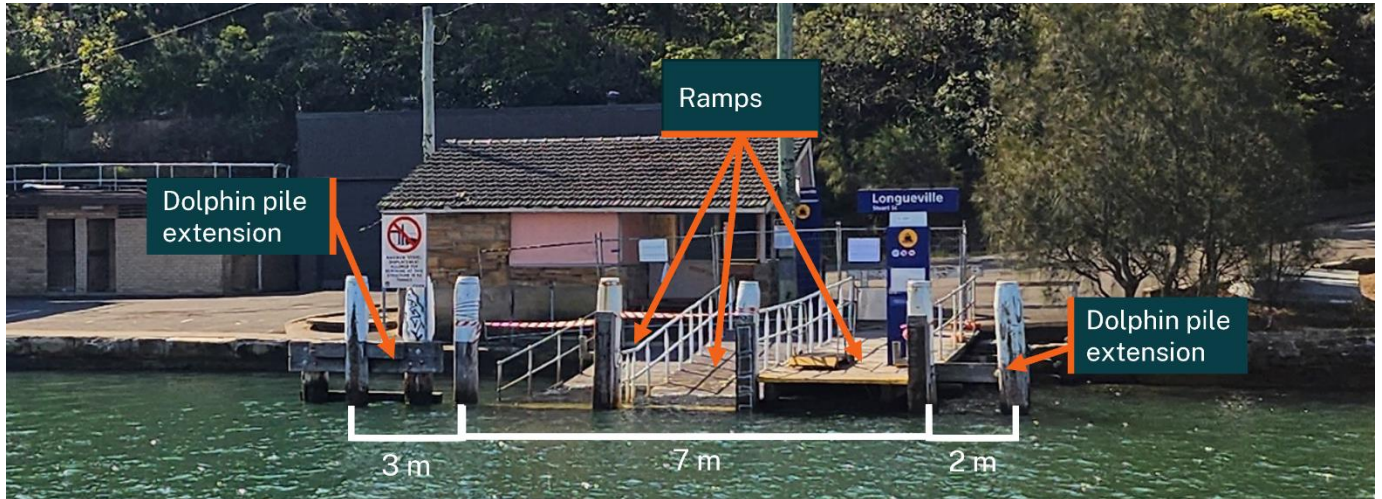
1.165 Longueville Wharf was similarly built of timber on a base of timber piles. It differed from the other four wharves on the river as far as it utilised three separate ramps of different height to address various tidal heights (Figure 37). Higher tidal levels were challenging due to highest ramp being significantly lower than a 24 m ferry's deck. This wharf had a berthing face of approximately 12 m due to an additional two dolphin³² type pile structures at either side of the wharf face.

1.167 At higher tides such as those above 1.8 m, the three ramps could become inundated with water and not allow access to the ferry without actual movement through water. Attempts to use the wharf in these conditions decreased safety and resulted in steep angles of gangway incline.

Figure 37: Longueville Wharf – fixed structure

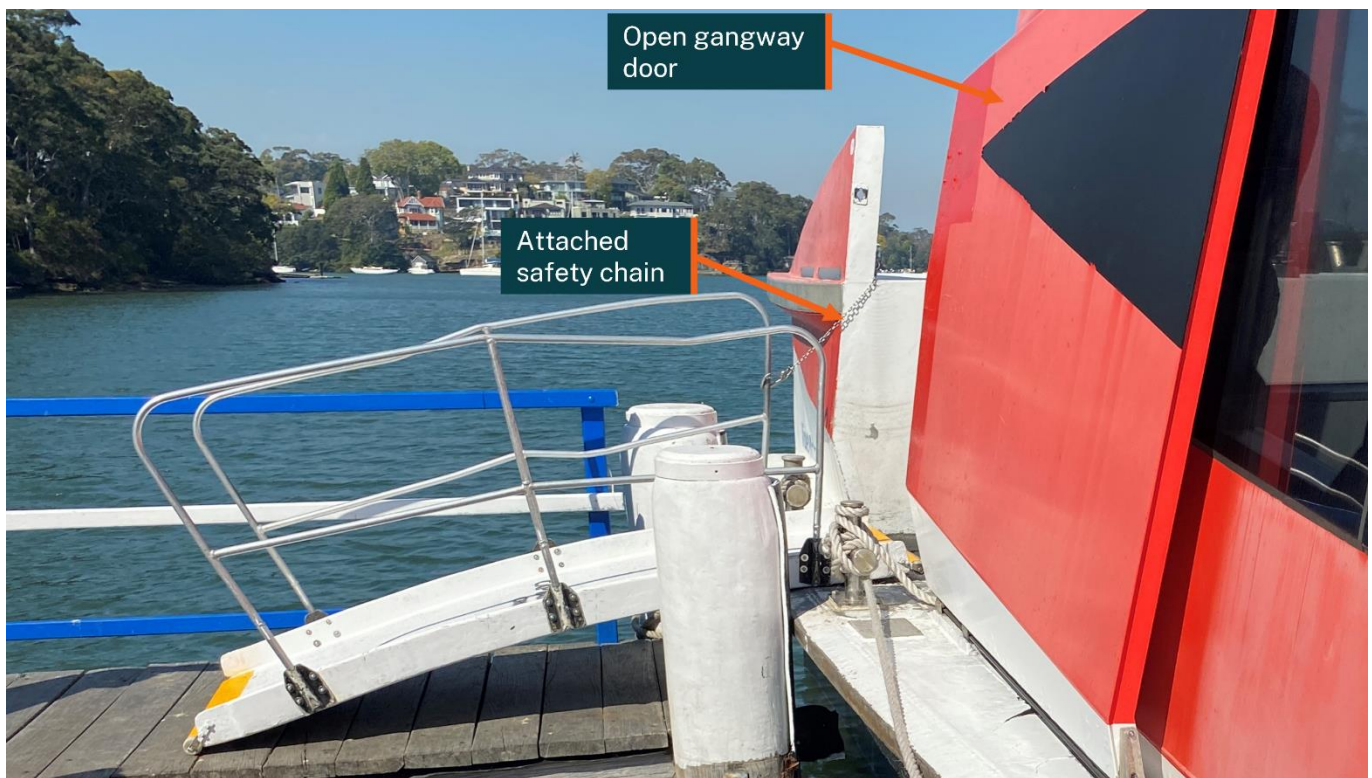
Figure 41: Gangway with safety chain attached

- 2.12 On the day of the incident, it was noted that the safety chain was not attached from vessel to gangway. It was also noted that during the berthing and POB recovery operations, the passengers were not kept clear of the forward working deck. On both occasions, the port cabin door remained open which allowed students to gather around the open gangway area. The lack of control of students on the working deck, permitted the student 19 to step into the open gangway door and jump into the water while the Deckhand went to obtain the recovery ladder.

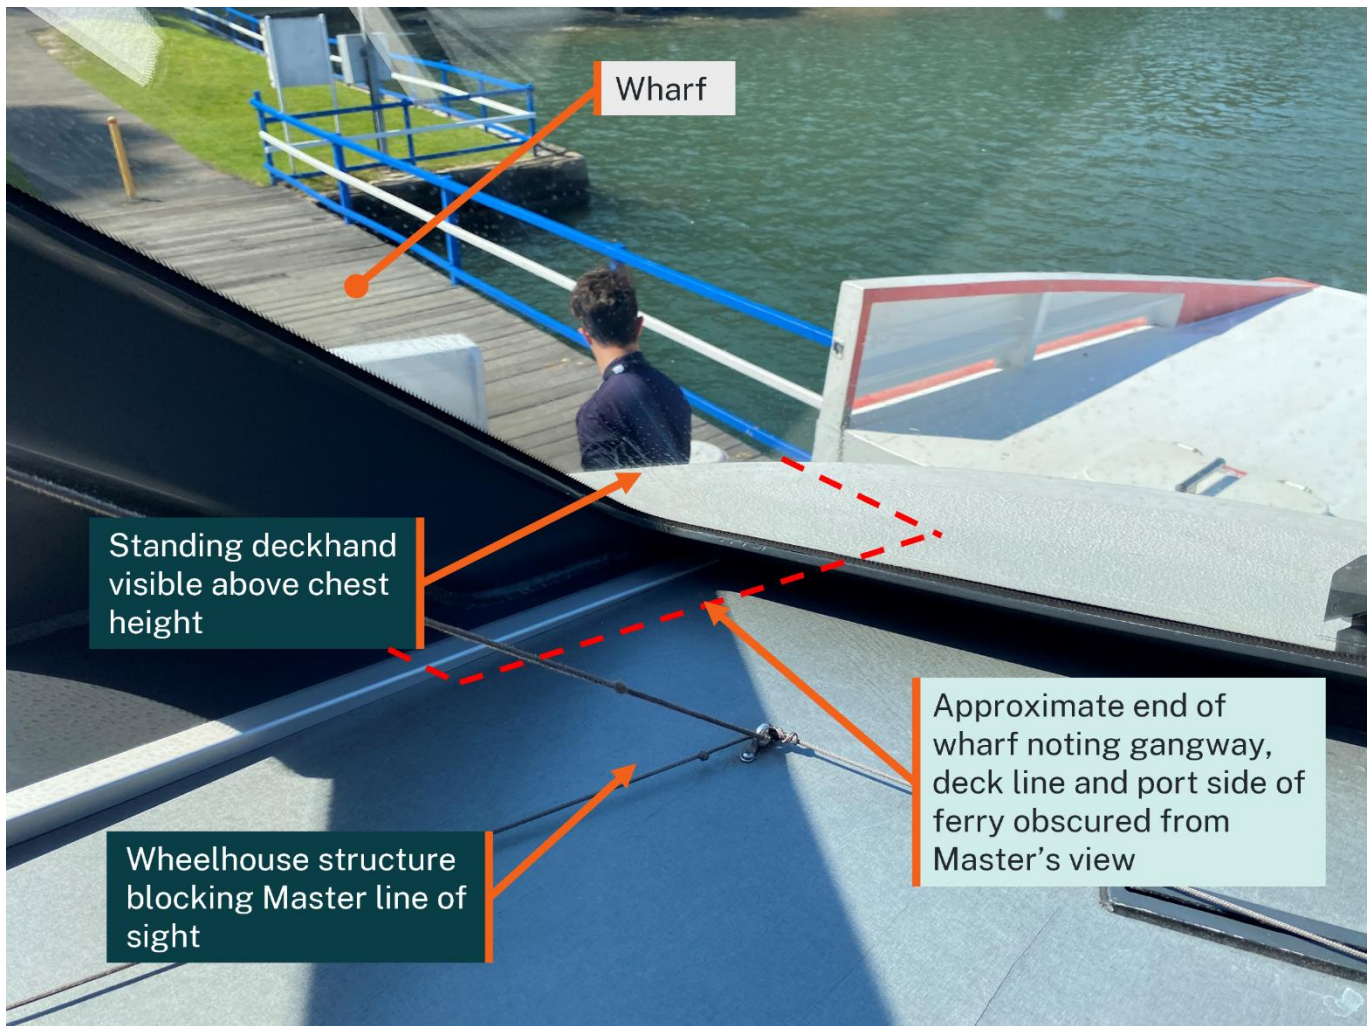
- 2.26 The line of sight restrictions resulted in the Master having to rely on CCTV and their Deckhand to assist and warn (via hand signals and voice communication) the Master of potential hazards. Such hazards included the ferry not maintaining a stable position against the wharf resulting in the potential for the gangway falling into the water.

Figure 42: View of working deck from Master's position

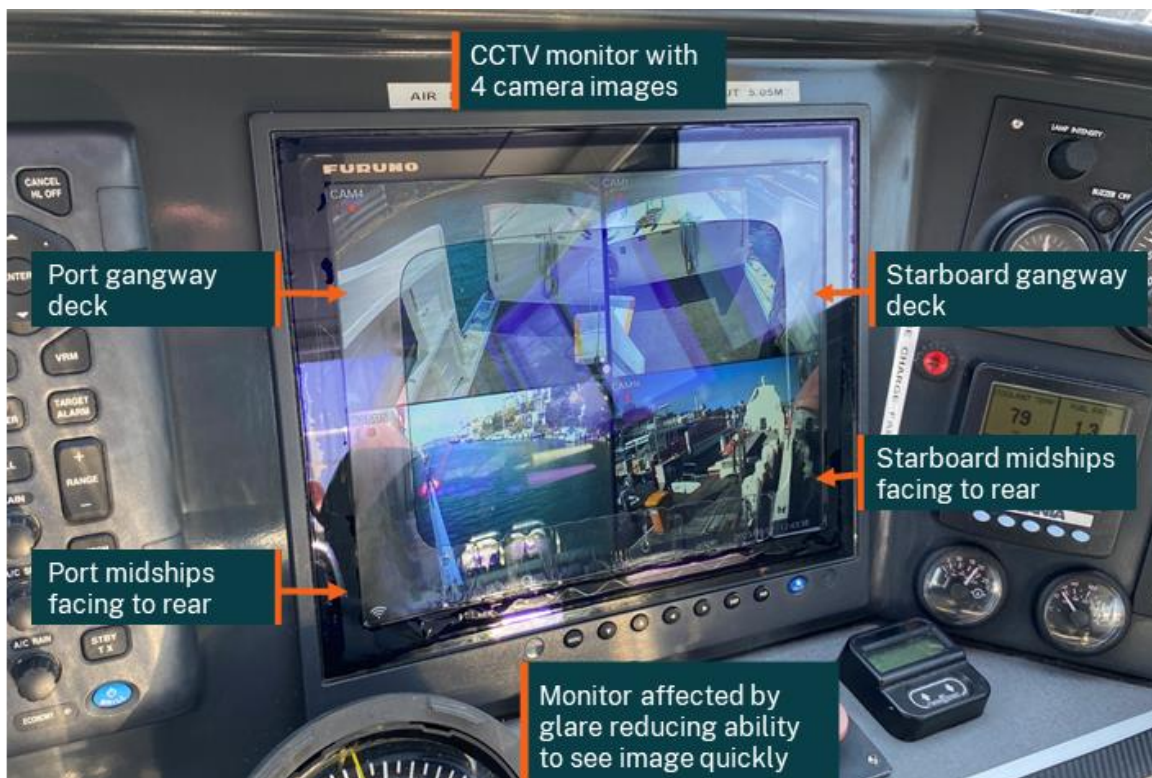
Figure 43: CCTV monitor showing images from 4 cameras with reflections from other sources

- 2.28 When a Master utilised any CCTV monitor, their concentration was focused on the monitor, and away from the forward working deck where the berthing and gangway operations were undertaken. Several challenges could arise in using the CCTV monitors as configured at the time of the incident. These challenges included glare affecting the clarity of the monitor's image during daylight, hindering the Master's ability to quickly glance at it (Figure 43). In addition, the partitioning of the monitor into 4 small camera streams potentially further increased the amount of concentration and time a Master utilised when viewing the monitor.

- 2.29 Without direct visual reference cues of the vessel's position relative to the wharf, a Master could lose situational awareness when attempting to monitor operations looking at screens located inside the wheelhouse. The likelihood of distraction also increased as a Master attempted to carry out multiple tasks requiring a change of focus on multiple items. While utilising the CCTV screen, a Master's attention was focused away from the gangway location. When a Master focused their attention on the internal CCTV screens, they risked of a reduction of their situational awareness to external factors. At such a time, a potential loss of situational awareness increased the likelihood that external factors (wash from passing vessels, high wind gusts, vessel position, gangway monitoring, passenger crowding etc.) could potentially affect the berthing process before the Master recognised and reacted to their existence.

- 2.32 As highlighted above, the default set up of camera angles shown on the CCTV screens were such that none of the images clearly showed the vessel position in relation to gangway and wharf interface. OTSI observed that two large CCTV monitors on the wheelhouse console displayed rearward facing images (Figure 25). These images, while beneficial in providing visibility during a reversing manoeuvre, could not assist the Master during berthing and gangway operations.
- 2.33 As a consequence of those limitations the Master primarily relied on a less reliable control of communication from the Deckhand regarding the safe securement of the gangway and vessel to the wharf.

- 2.31 OTSI noted that while the CCTV screens potentially aided a Master in monitoring the berthing process and transfer of passengers, their use was not without risk. A clear line of sight to the gangway would have removed the need for aids such as CCTV during the gangway operation and likely improved crew teamwork.

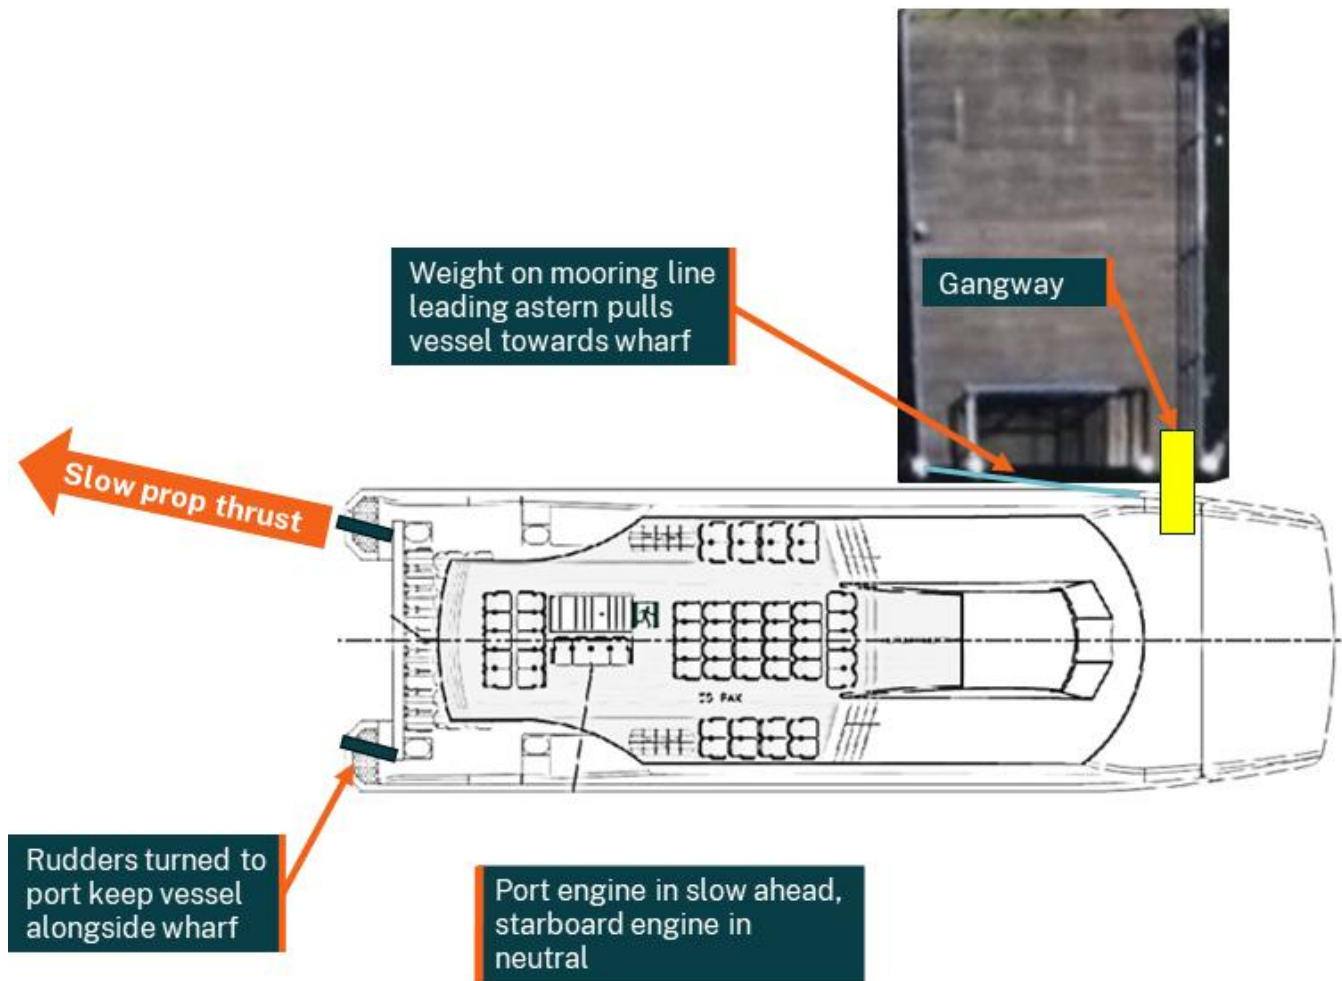
Figure 45: Image showing vessel berthed alongside wharf, using engine thrust and rudders to stay alongside running ahead

- 2.51 As wharf berthing face length decreases, the amount of vessel that can be supported by the wharf is also reduced. The reduced support provided by the wharf requires a Master to utilise engine thrust to stabilise the vessel alongside the wharf. When a Master engages forward thrust (running ahead), the vessel is pulled alongside the wharf by the mooring line deployed by their crew. Any subsequent movements by the vessel can be corrected by small movements of the steering (Figure 45).

- 2.52 In calm to moderate conditions, common practise in the marine industry is to engage one engine ahead, to maintain the vessel position alongside a wharf. When one engine is utilised a reduced force on the mooring line occurs, lessening the likelihood of it breaking and reducing wear. If conditions (tide and wind) require both engines to maintain position, a Master will often instruct crew to place a second line on the wharf to maintain position.

- 2.53 When engines run ahead, water is pushed by the propeller towards the stern and flows over the rudder surface allowing a Master to make small rudder adjustments to keep the vessel stable. When combined with the natural tendency of the mooring line to pull the vessel towards a wharf, a vessel is likely to remain in a stable position using that berthing technique.

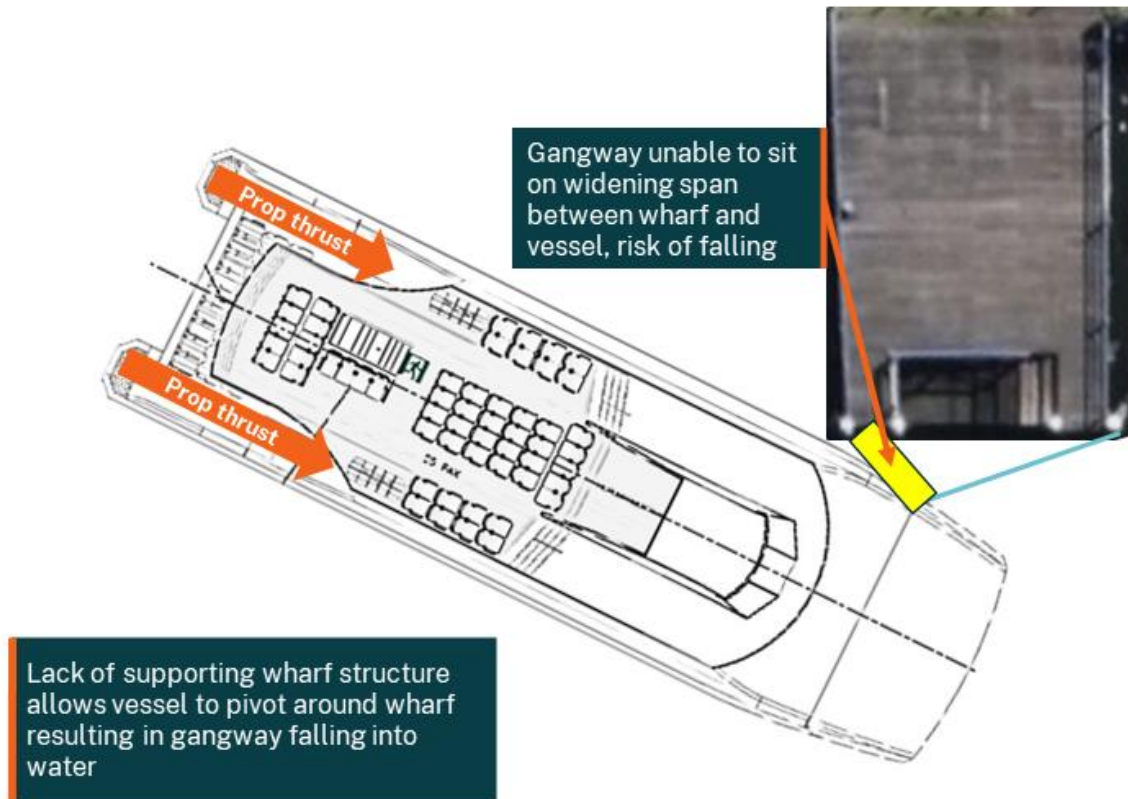
Figure 47: Image showing vessel with thrust engaged astern, directing water flow away from rudders rendering them ineffectual

- 2.57 When a Master increased or varied astern thrust, an unsupported stern was likely to swing like a pendulum, resulting in the Master further increasing or varying thrust to compensate. Varying the engine thrust would result in a mooring line alternately stretching and contracting (Figure 47).

- 2.59 When a bow moves away from the vicinity of the wharf, a gangway could quickly become unstable and eventually fall off either the wharf or vessel (Figure 47).

- 2.60 A Master requires significant concentration to maintain a vessel in position considering the result of external and internal forces acting on it. If the Master fails to respond effectively to the vessel's pendulum motion, a risk of the gangway becoming dislodged significantly increases. On the day of the incident, both wind and tide, while not strong, acted upon the vessel to move it away from the wharf (Figure 48 on page 71). These factors highlight that the practice of running astern presented significant challenges to maintain safe vessel berthing for gangway operations on small wharves.

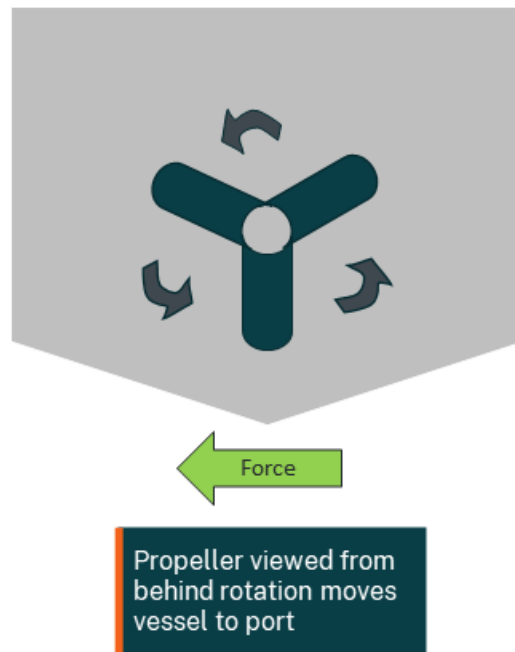
Figure 49: Transverse thrust effect

- 2.64 The direction of propeller rotation created a sideways force known as transverse thrust, commonly referred to as ‘propeller action or walking’ in the maritime industry. Transverse propeller thrust has the effect of placing a sideways force on the propeller shaft moving the propeller (and stern of a vessel) in the direction of propeller rotation. When that effect is viewed from behind a vessel a propeller turning in an anticlockwise rotation will move a vessel stern to port (Figure 49: Transverse thrust effect).

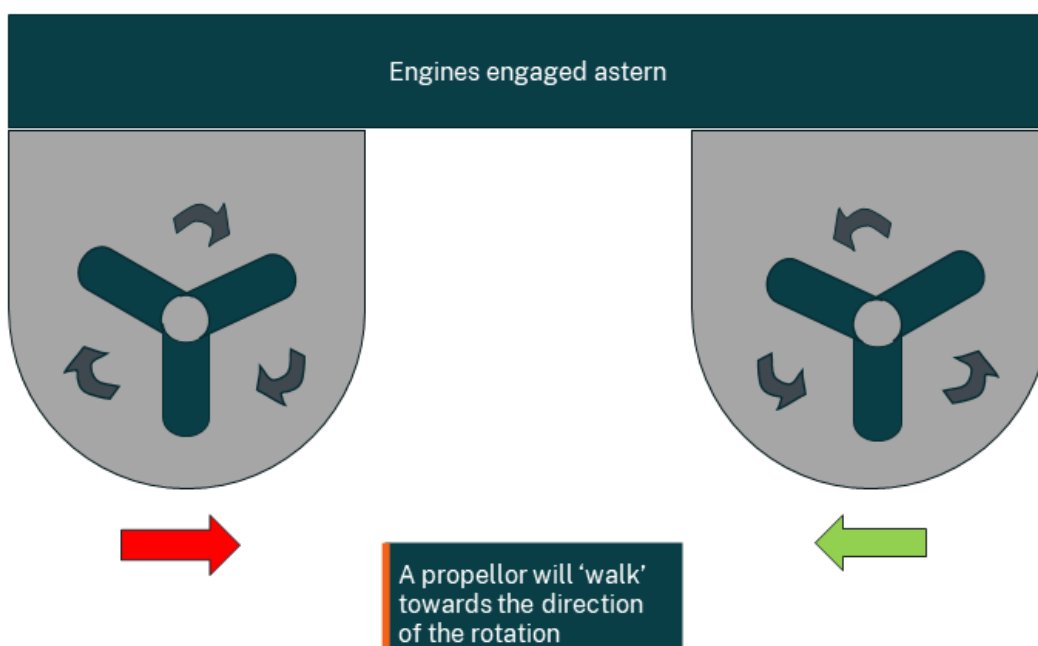
Figure 50: Catamaran in astern viewed from behind

2.65 *Violet McKenzie* was a catamaran (twin Hull) vessel and had two propellers: one at the rear of each hull. When viewed from behind and engaged in astern thrust, the propellers turned inwards in opposite directions, with the transverse forces in balance if the propeller speeds were the same. The resulting transverse force from the propellers would vary, dependant on the speed each propeller rotated. Successful management of the net transverse force presented a challenge for the Master to manoeuvre using astern thrust.

- 2.66 When *Violet McKenzie's* Master attempted to keep the ferry in position at Riverview Wharf, the tide, wind, propeller action and lack of supporting wharf structure destabilised the ferry, with it slowly moving away from the wharf.

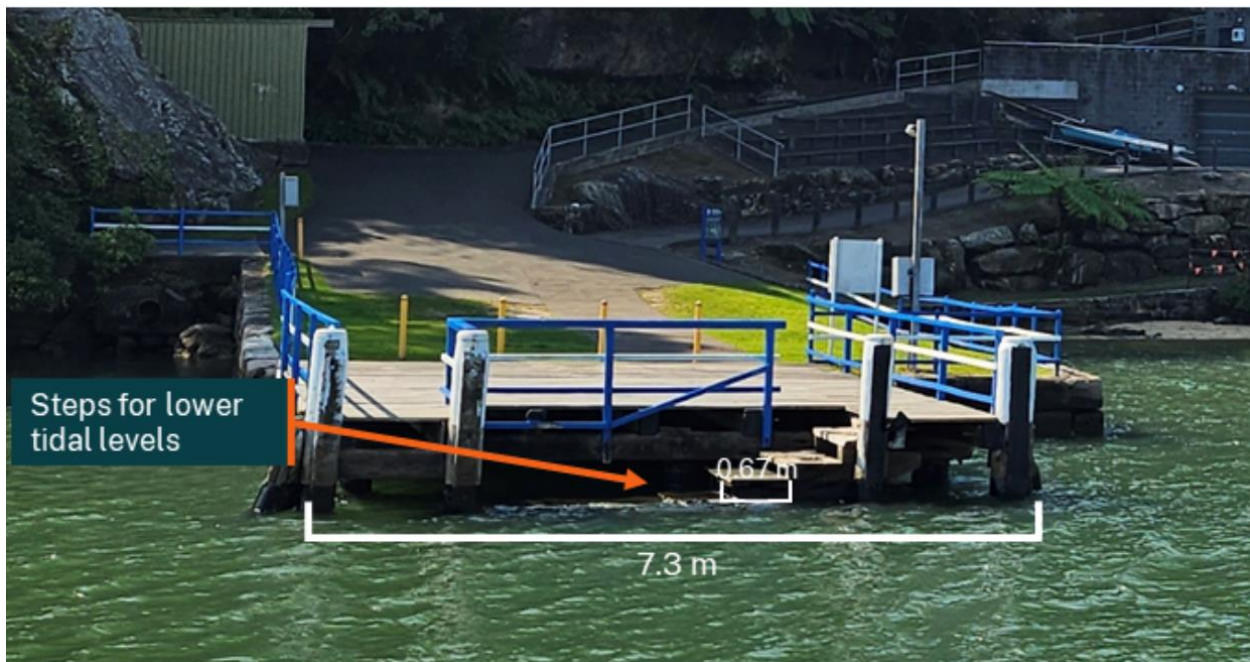
Figure 51: Involved wharf layout at time of incident

2.77 At the time of the incident, the involved wharf did not have several safety features, such as a ladder for emergency egress from the water, clearly marked visual delineations of the steps/wharf face and mooring points for vessels to secure on (Figure 51).

2.78 While the absence of these items did not contribute to the incident or influence the recovery of the students from the water, there were identified safety improvement opportunities which OTSI discussed with the wharf owner, Saint Ignatius' College, Riverview, after the incident.
