**Special Commission of Inquiry Into the
Glenbrook Rail Accident**

Interim Report

June 2000

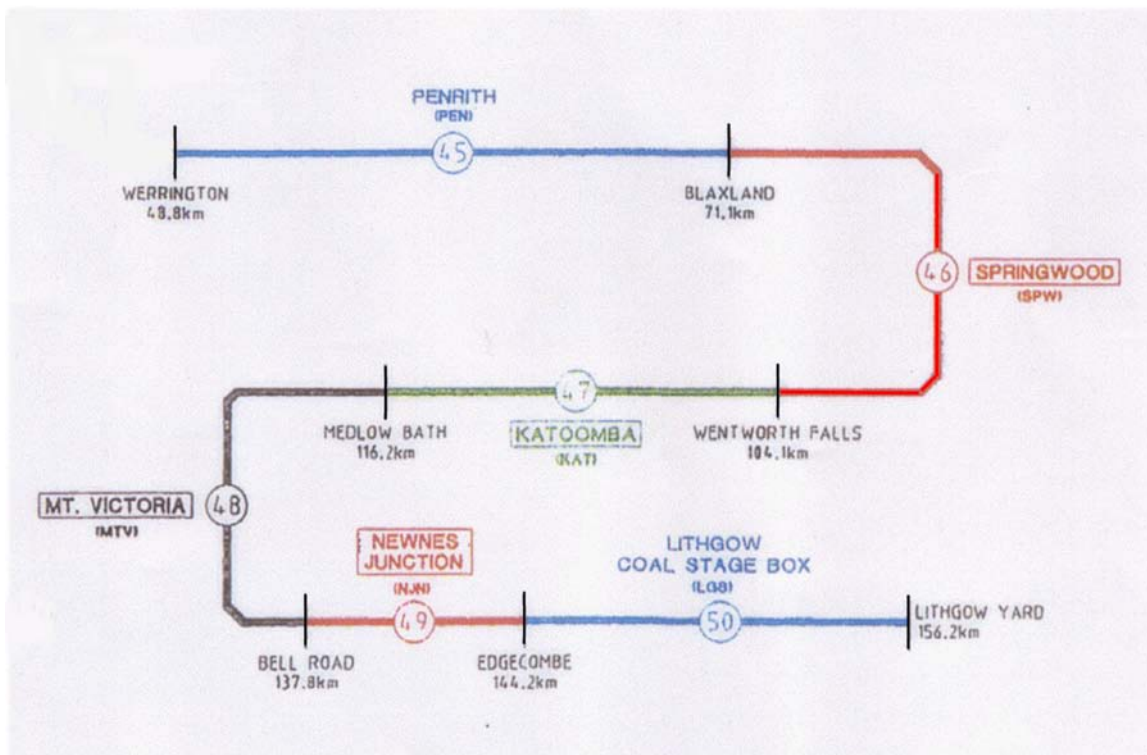
Figure 9 - Portion of diagram depicting areas under control of signal boxes

The geographical features, together with the absence of a train indicator board, made this area hazardous. It was described in evidence as a “dark area” or “no man’s land”, by which was meant that the signaller did not know, other than by the above means, the position of any trains in that section.

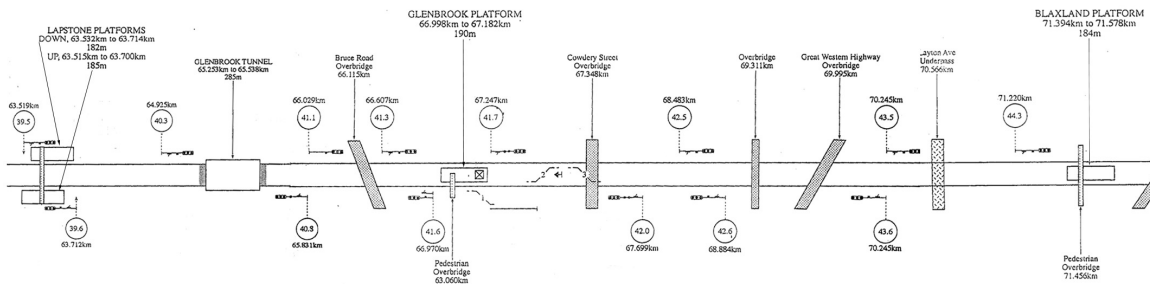
Figure 10 - Location of signals from Lapstone to Blaxland

In order to understand the signalling involved in this accident there are four relevant automatic signals on the up line that figure prominently. The first is signal 42.0 situated a few hundred metres west of Glenbrook railway station, the second is signal 41.6 situated just east of Glenbrook railway station. The third is signal 40.8 which is located approximately 1.1 kilometres east of signal 41.6. The fourth is signal 39.6 situated some hundreds of metres east of the Glenbrook tunnel and prior to Lapstone station. Glenbrook tunnel is another hazard to trains since it is unlit and has a bend within its confines.

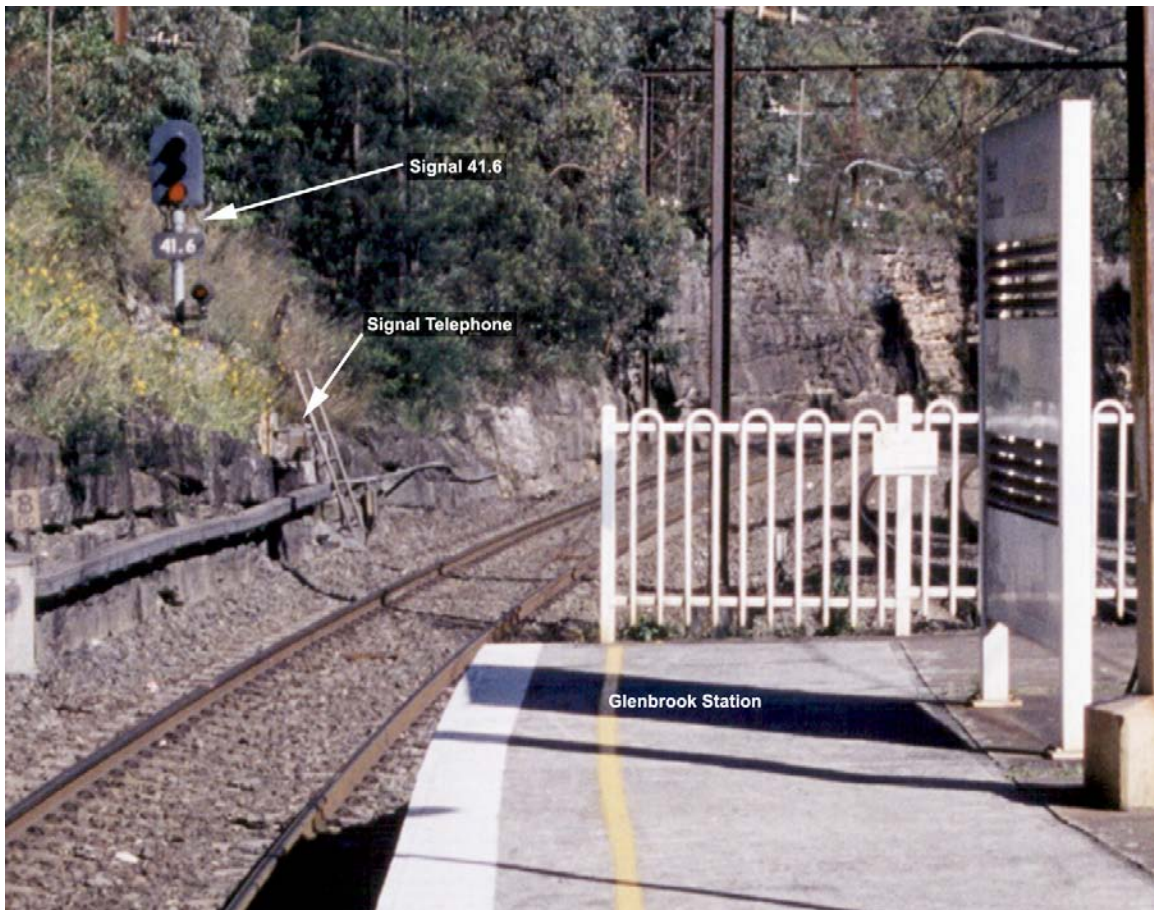
Figure 15 - View of signal 41.6 and its telephone from Glenbrook railway station

When the Indian Pacific arrived at Glenbrook railway station Mr Marshall and Mr Willoughby expected signal 41.6 to be at stop because signal 42.0 had been at caution.

Mr Marshall, who was driving the train, thought that signal 41.6 may have been in the stop position because the Indian Pacific had caught up with the train ahead, W532. For this reason the drivers waited about a minute to a minute and a half for the signal to clear. When this did not occur Mr Willoughby put on his visibility jacket, left the locomotive on the platform side, proceeded down the platform and down and across the ramp in front of the locomotive to signal telephone 41.6. He found this signal telephone was secured by a chain and an SL lock. It was the first signal telephone that he had found to be locked having used signal telephones many times. Evidence was given by other drivers that most of the signal telephones are unlocked. Mr Willoughby had to return to the locomotive to obtain an SL key and then return to the signal telephone. This brought about an additional delay of some minutes.

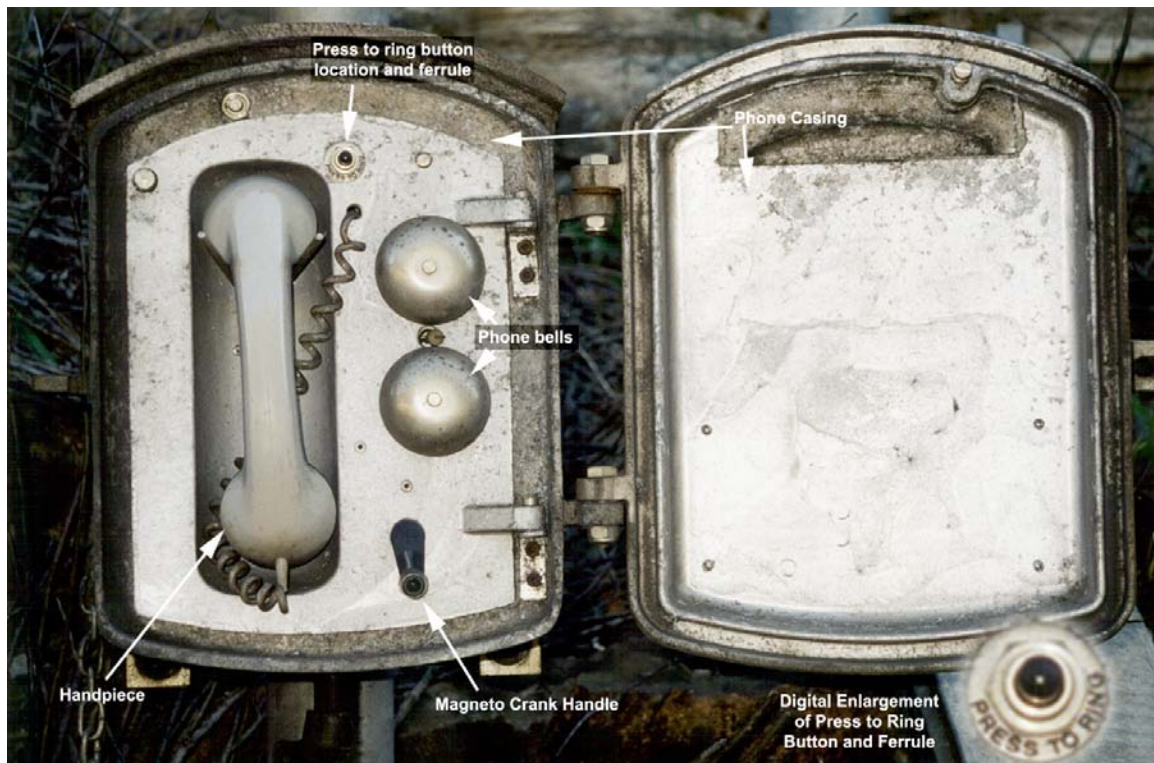
Figure 16 - View of signal telephone 41.6

According to Mr Willoughby, after Mr Mulholland had identified himself Mr Willoughby said “driver of the Indian Pacific signal 41.6 at Glenbrook. The signal is in the stop position”. Mr Mulholland then said “You are okay to go past the signal at stop and can you please report to me the indication of the next signal that you come across which is further down the track”.

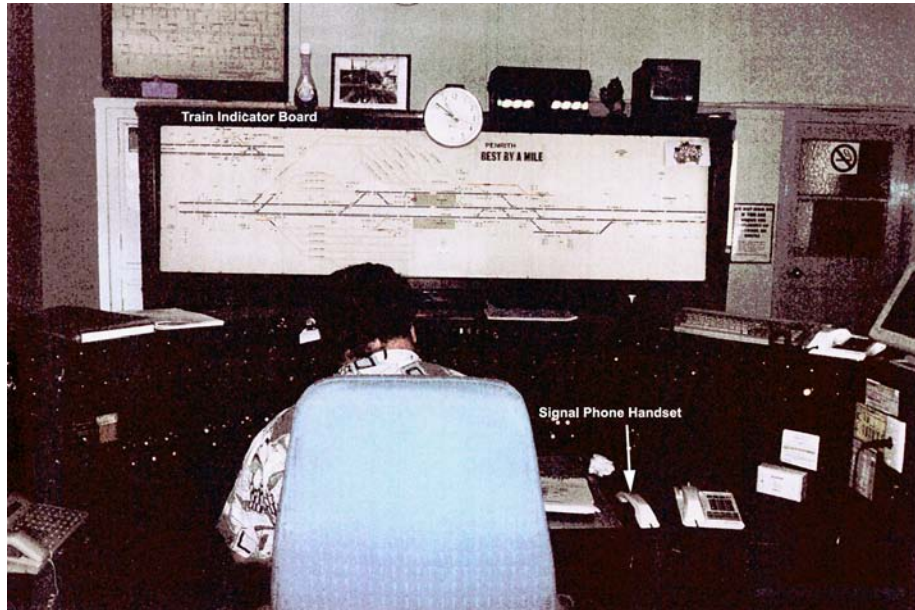
Figure 19 - Penrith signal box

The only sources of voices on the line were either background noise from Penrith signal box or someone on the party line from another signal telephone. If the latter had been the case, Mr Willoughby would have been able to hear the conversation clearly. Since he could not do so the only alternative was that background noises were emanating from Penrith signal box.

Mr Curtin said that if the handset in the Penrith signal box was placed on a table some distance from people having a conversation in the signal box, Mr Willoughby would make out voices but probably not the actual conversation.

The only other possibility, he said, was that a telephone on that party line somewhere else could have been left off the hook and there were some people conducting a conversation in the vicinity of the signal telephone. This is an unlikely scenario.
