Response to Mr Roy Butler MP

Otford Causeway betterment (photos attached)

OTFORD CAUSEWAY – Storms of 2023

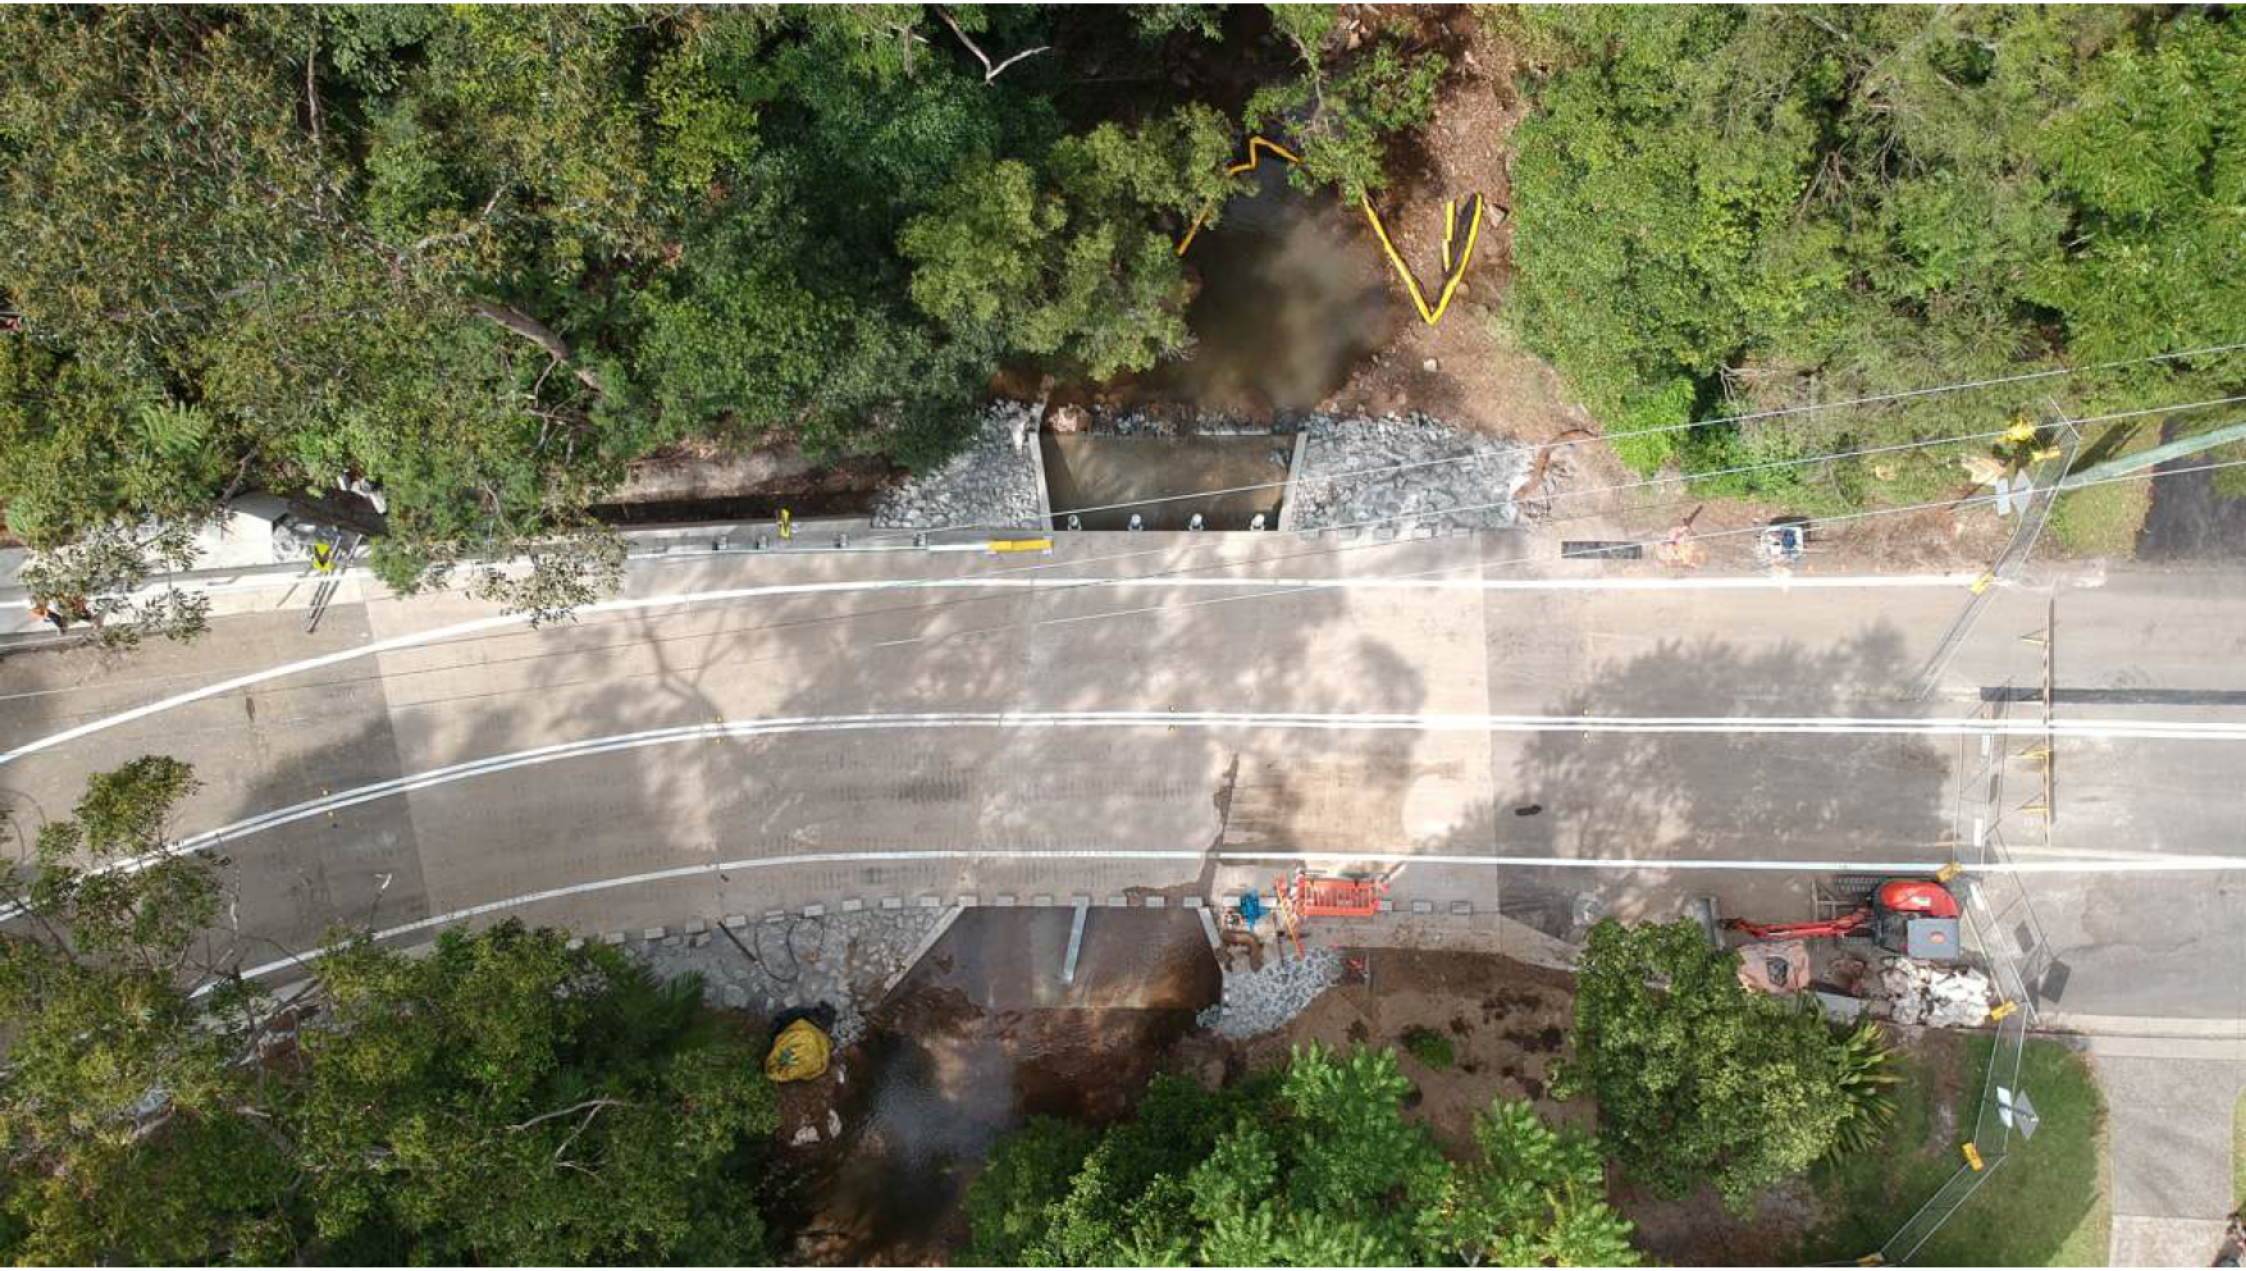
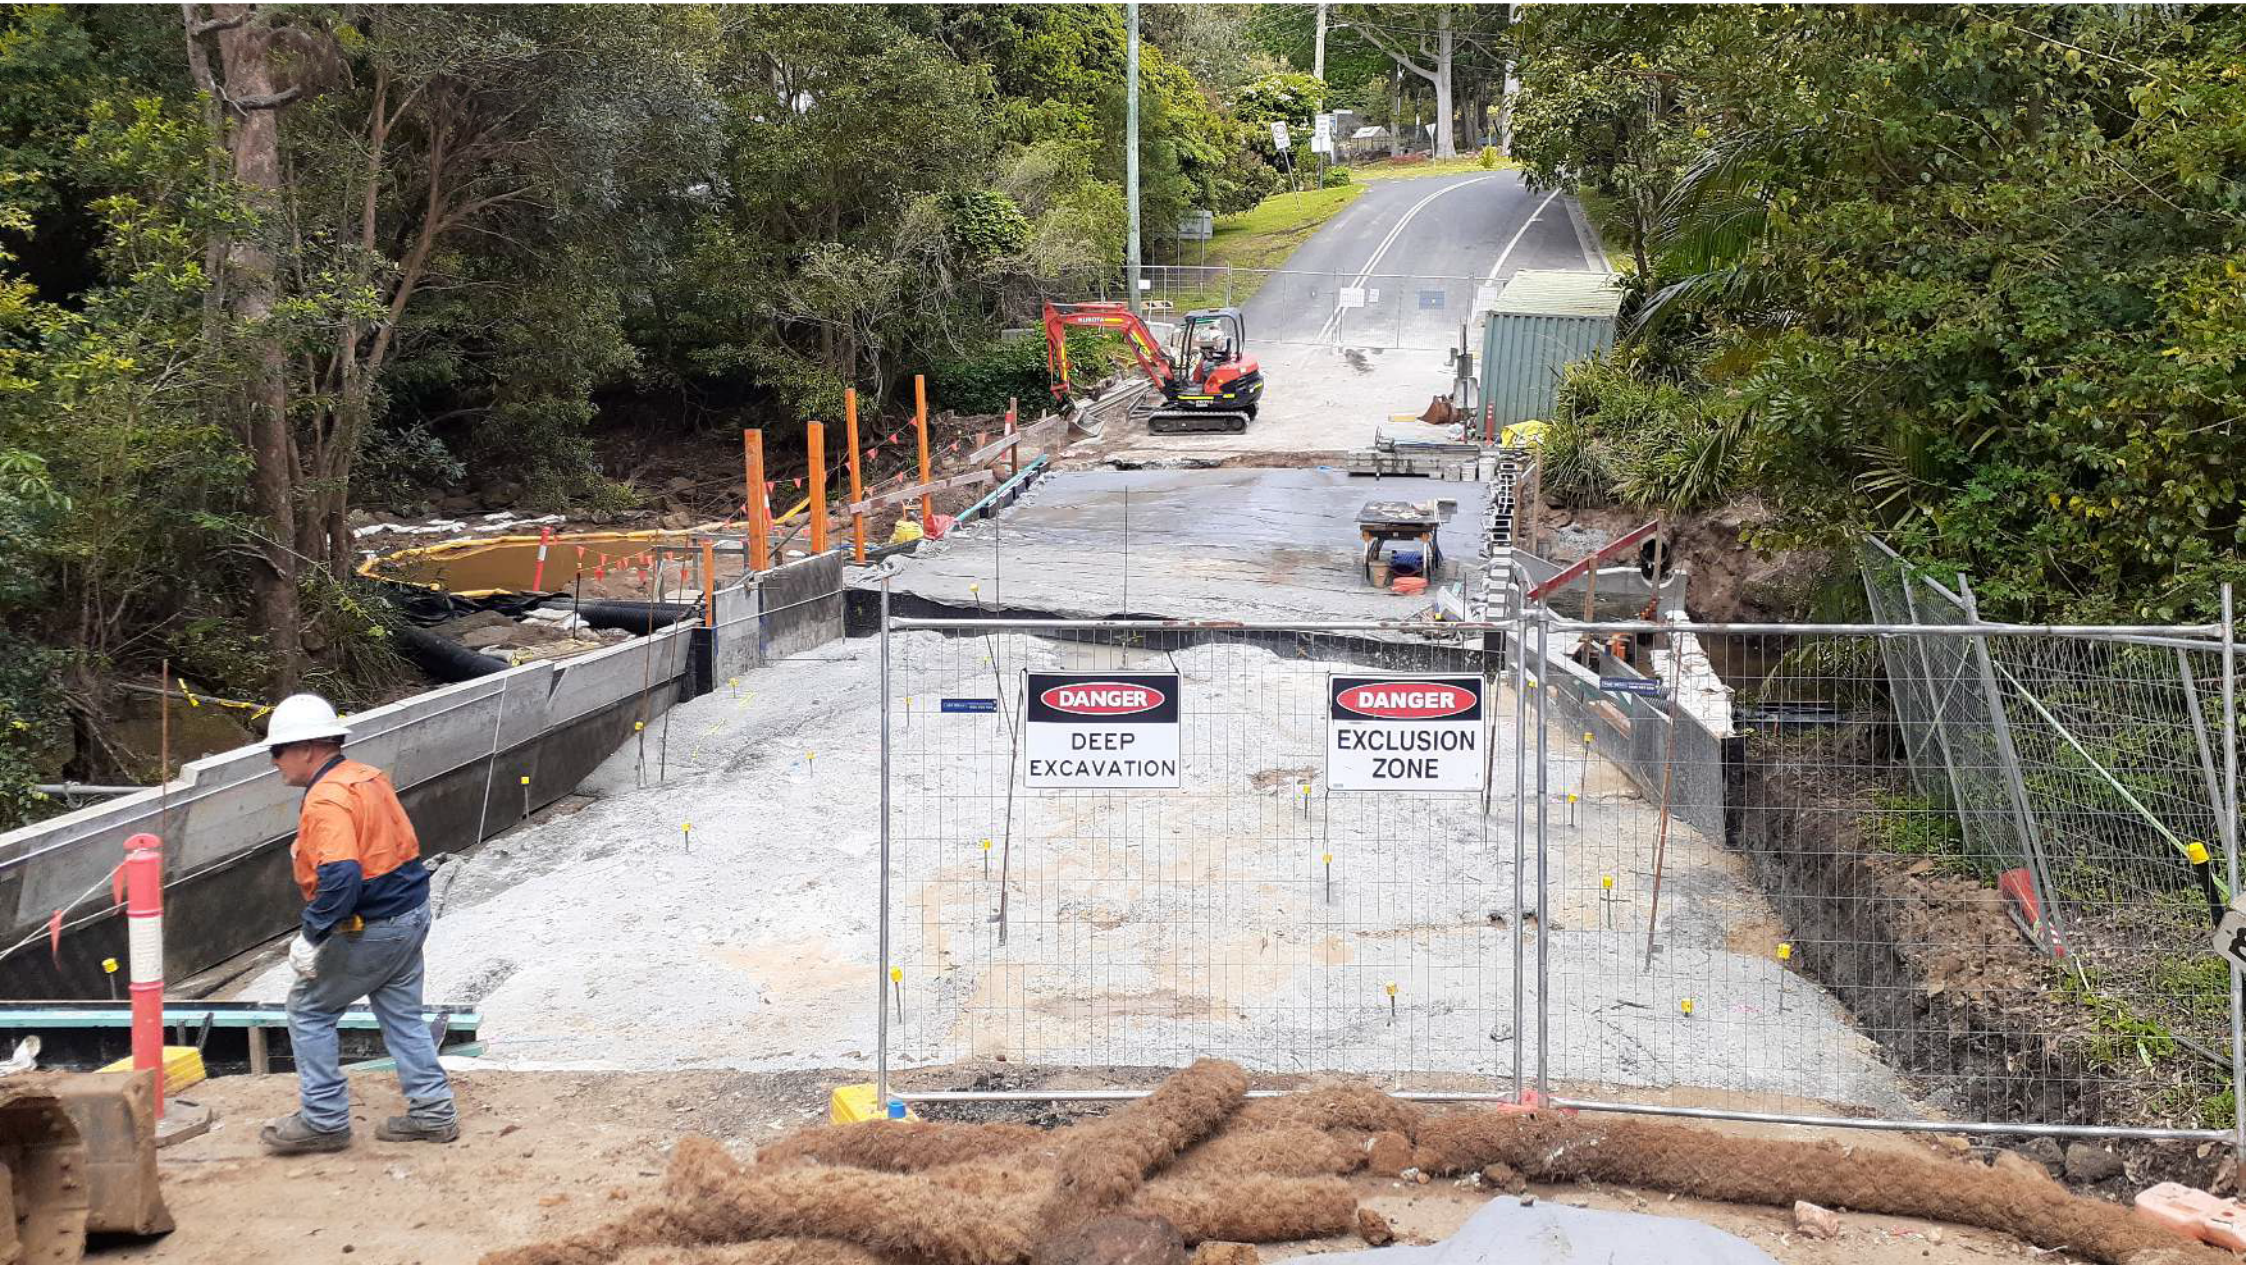
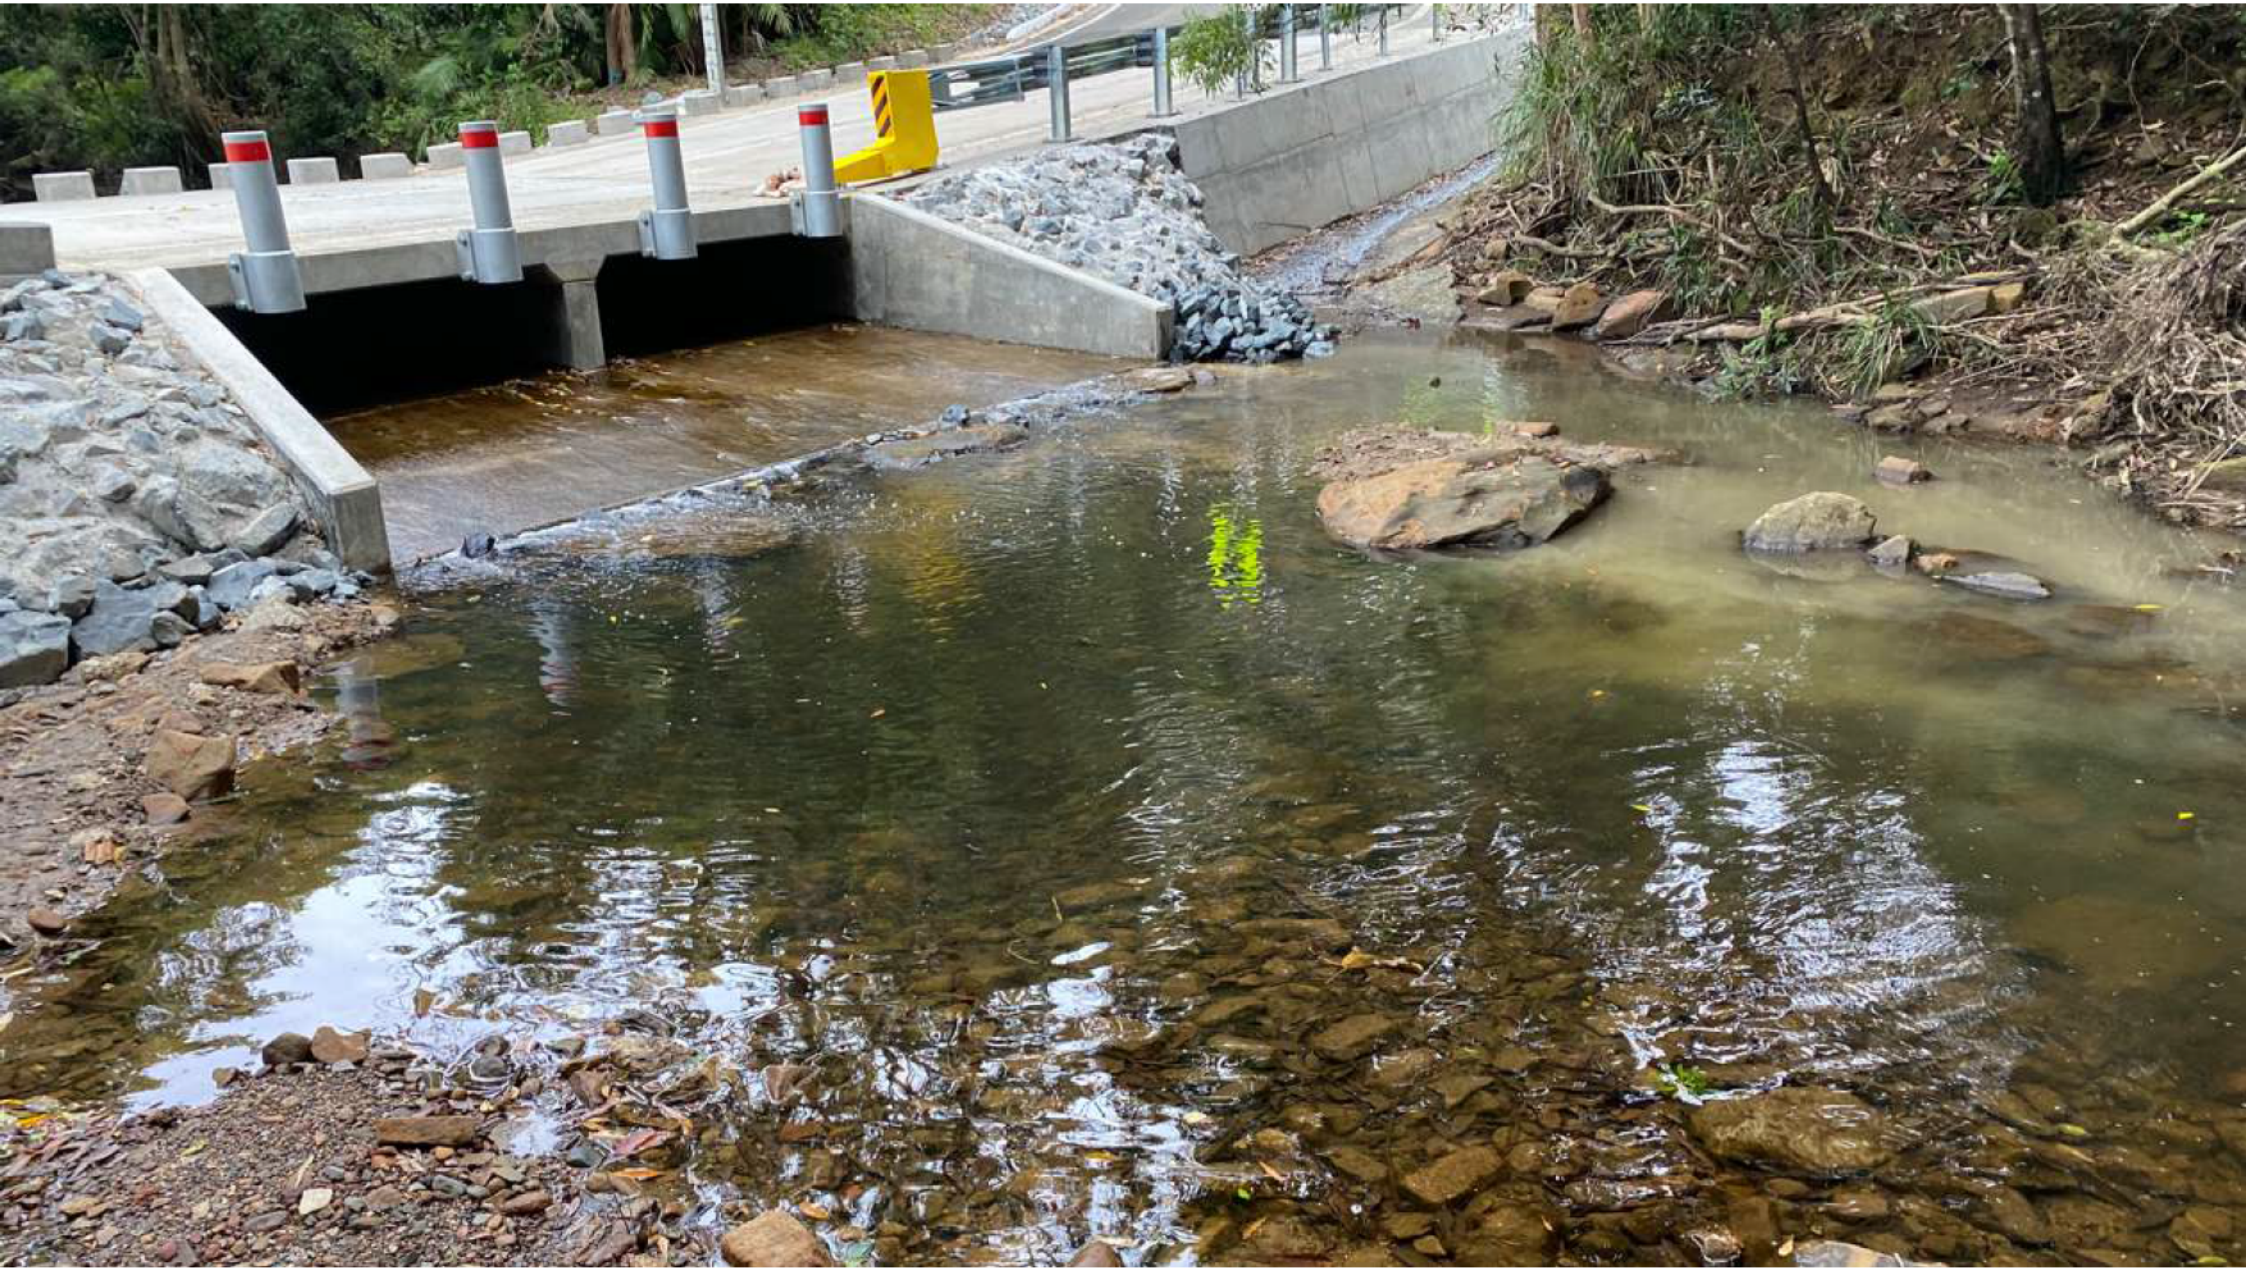
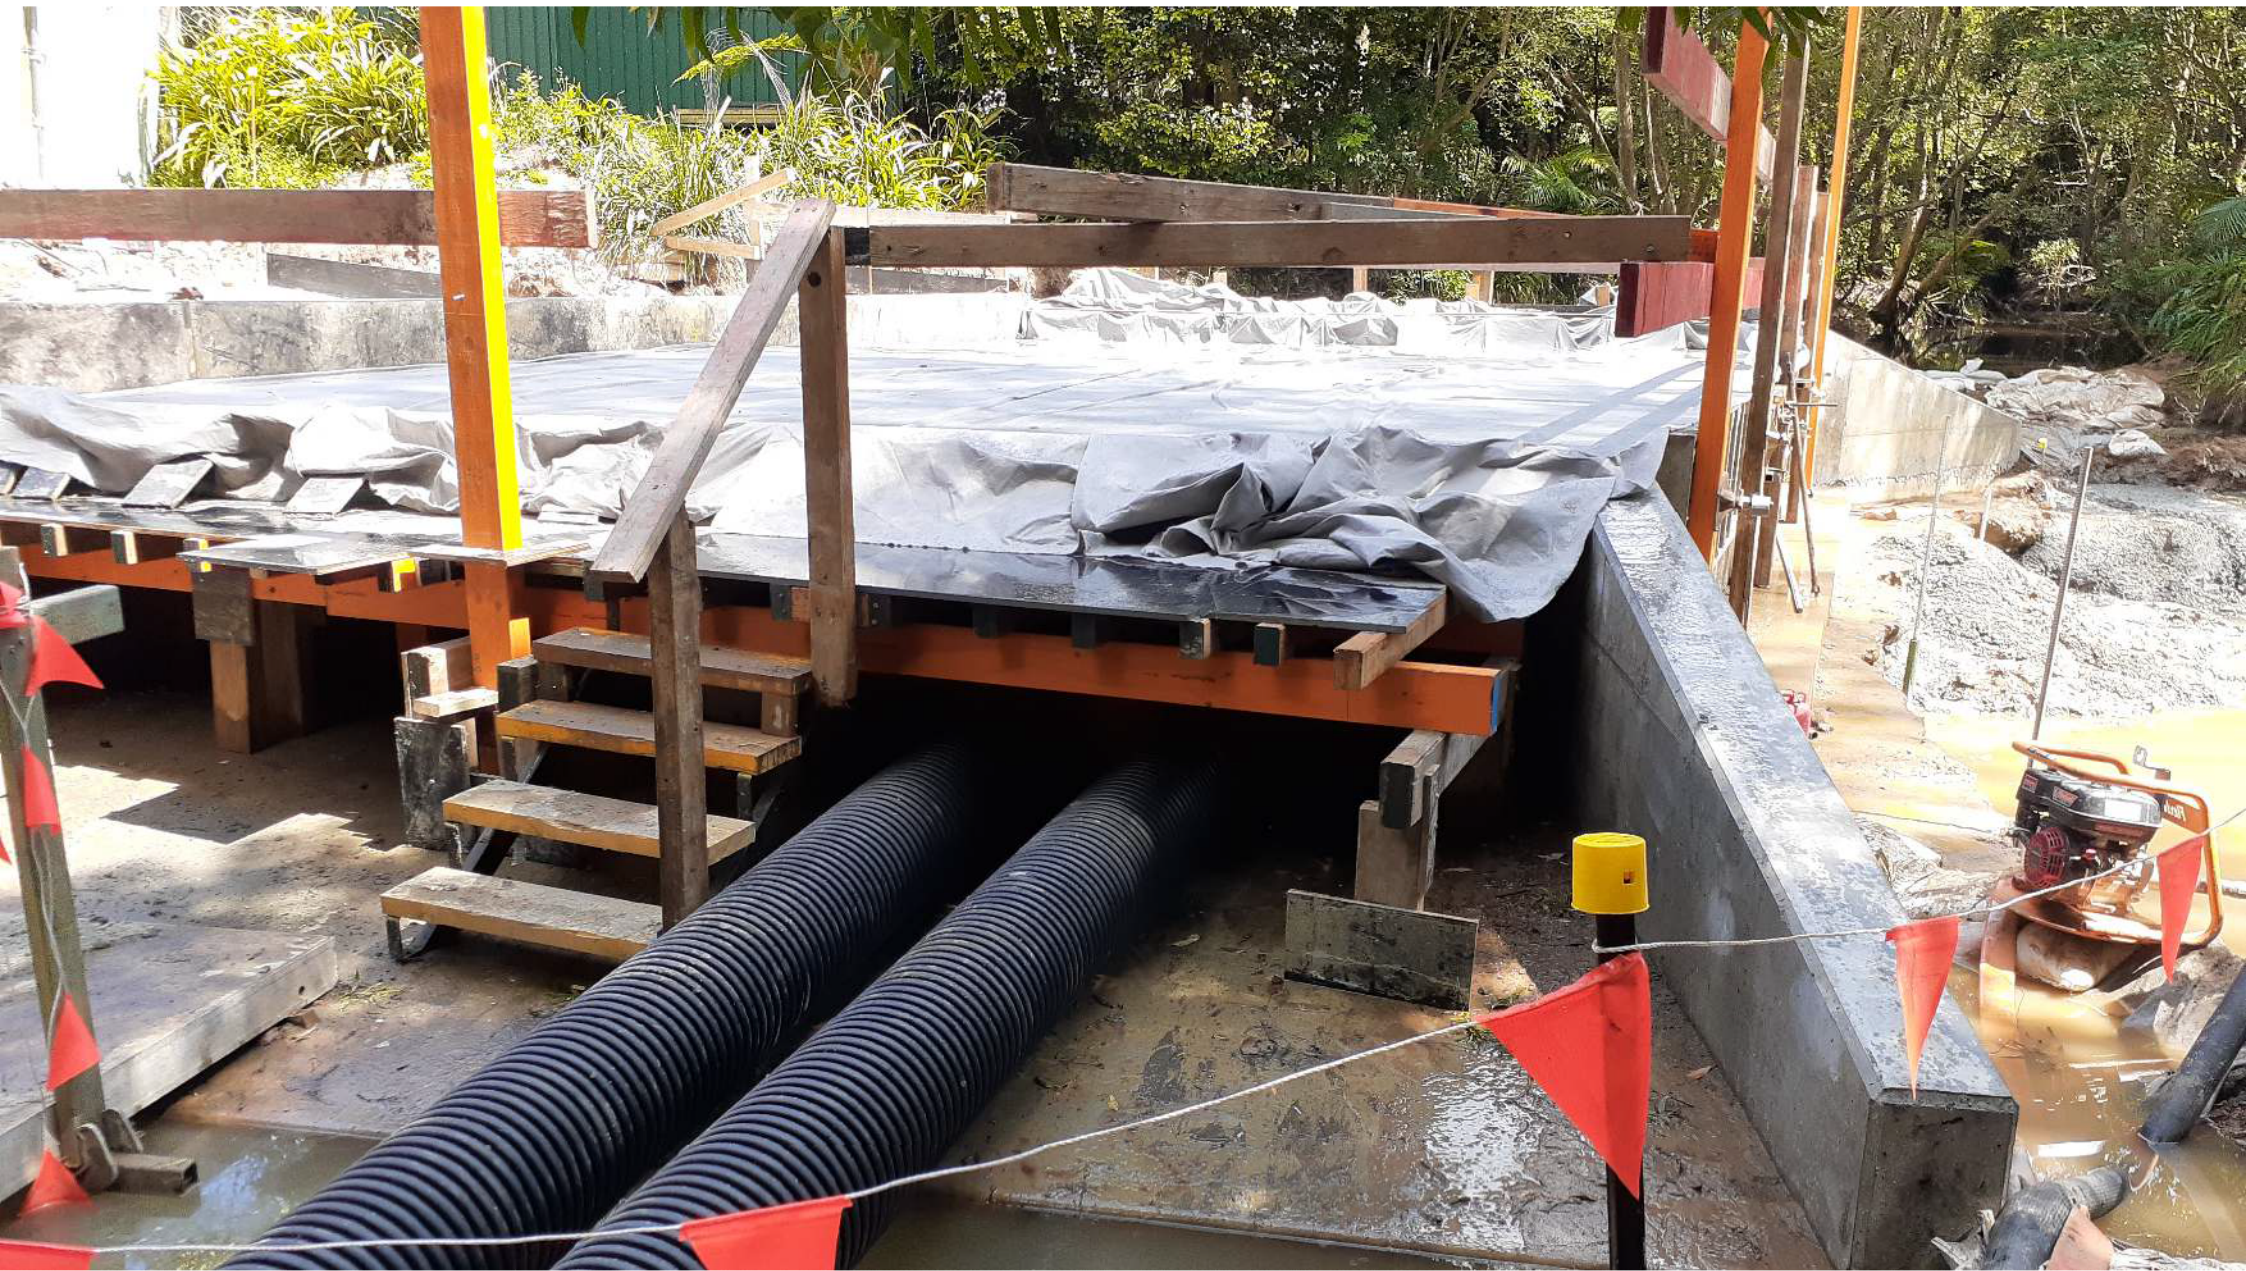
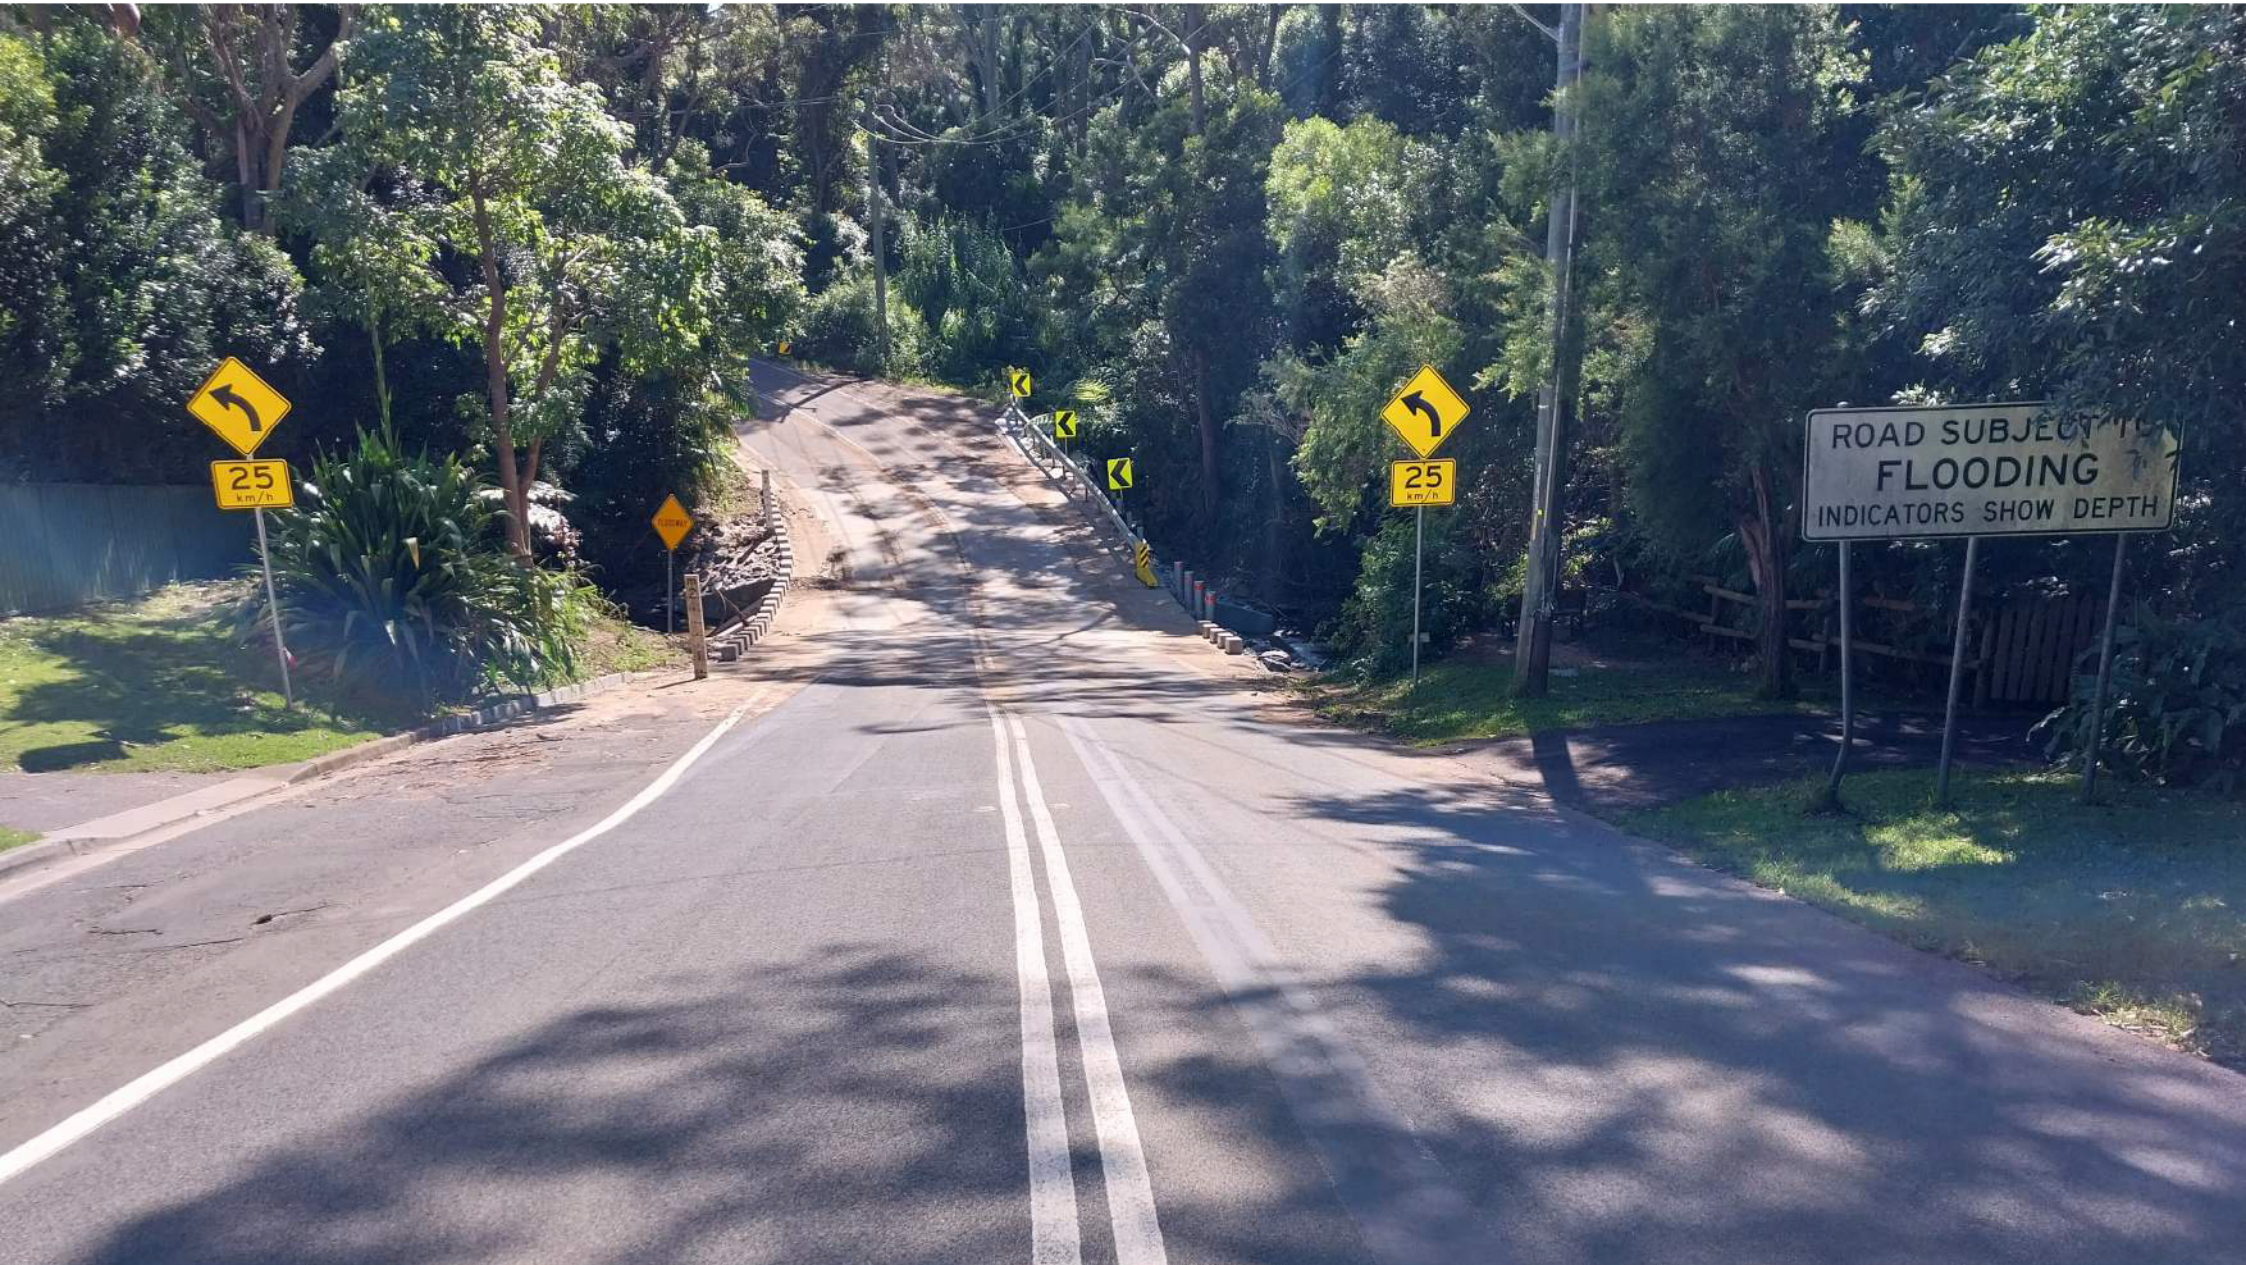
There were a number of elements of the causeway project that constituted “betterment” in the eyes of the funding body. This included various upgrades to increase the performance, safety, and Natural Disaster resilience of the asset. A summary of betterment items is provided below. Total approx. amount spent on betterment = **~\$112,000** (~7% of total expenditure)

- Installation of upstream culvert apron slab = ~\$25k (to better protect the causeway and to ensure longevity and resilience of asset in future storm events)
- Installation of upstream culvert wing walls = ~\$4k (to better protect the causeway and to ensure longevity and resilience of asset in future storm events)
- Installation of kerb & gutter and dish drains = ~\$12k (to improve site overland flow management)
- Increased length of castellated kerb = ~\$7k (to better protect the causeway and increase vehicular safety)
- Renewal and minor reconfiguration of surrounding linemarking = ~\$2k (to better suit current standards, better suit the new design, and increase safety)
- New road signage = ~\$12k (to better suit current standards, better suit the new design, and increase safety)
- New vehicle activated signage = ~\$50k (to increase safety)
